**FRANCO SCIORILLI**

**A History of Conservation at the Temple of the  
Winged Lions**

**JULY 9 2019**

**Lecture Hall, AL HUSSAIN BIN TALAL UNIVERSITY, Petra College for  
Tourism and Archaeology  
Wadi Musa, Jordan**

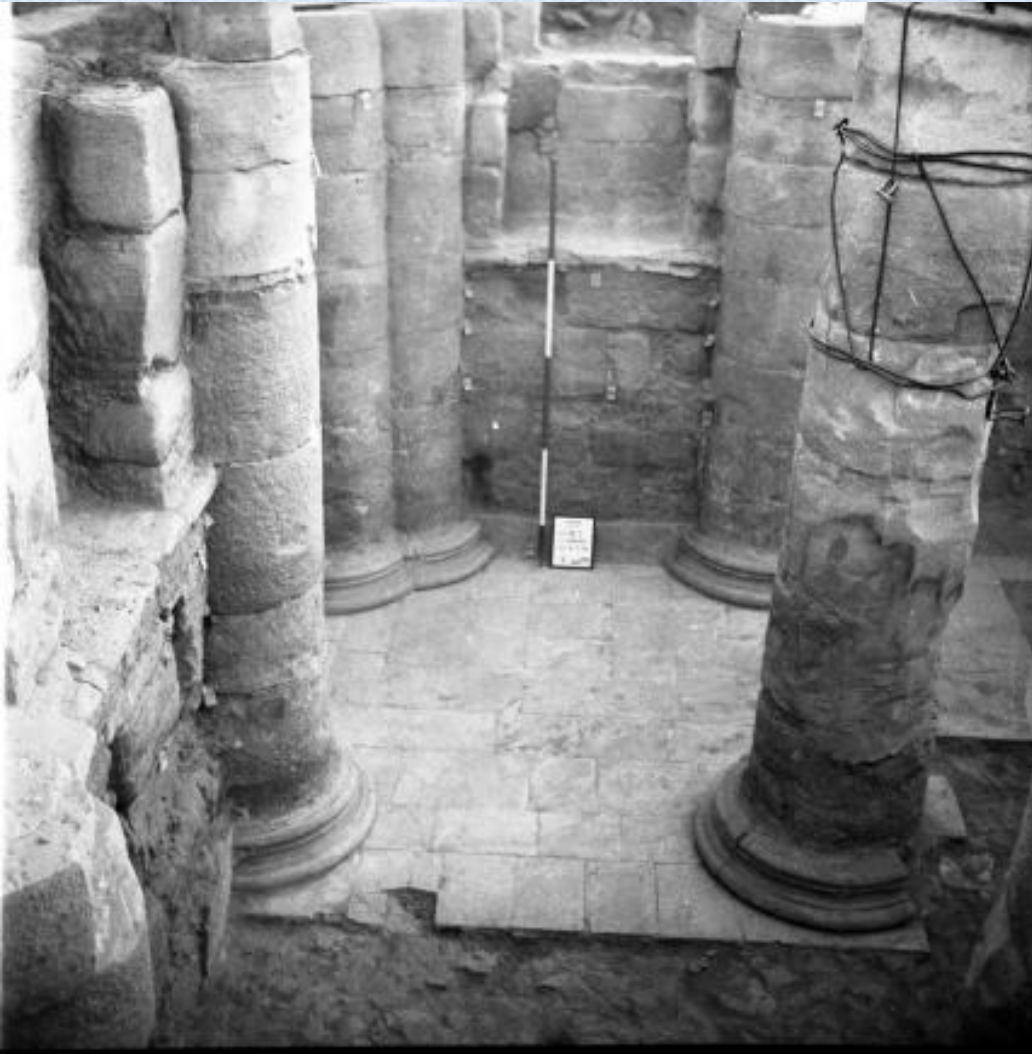
# Stabilization and consolidation of column 34 E

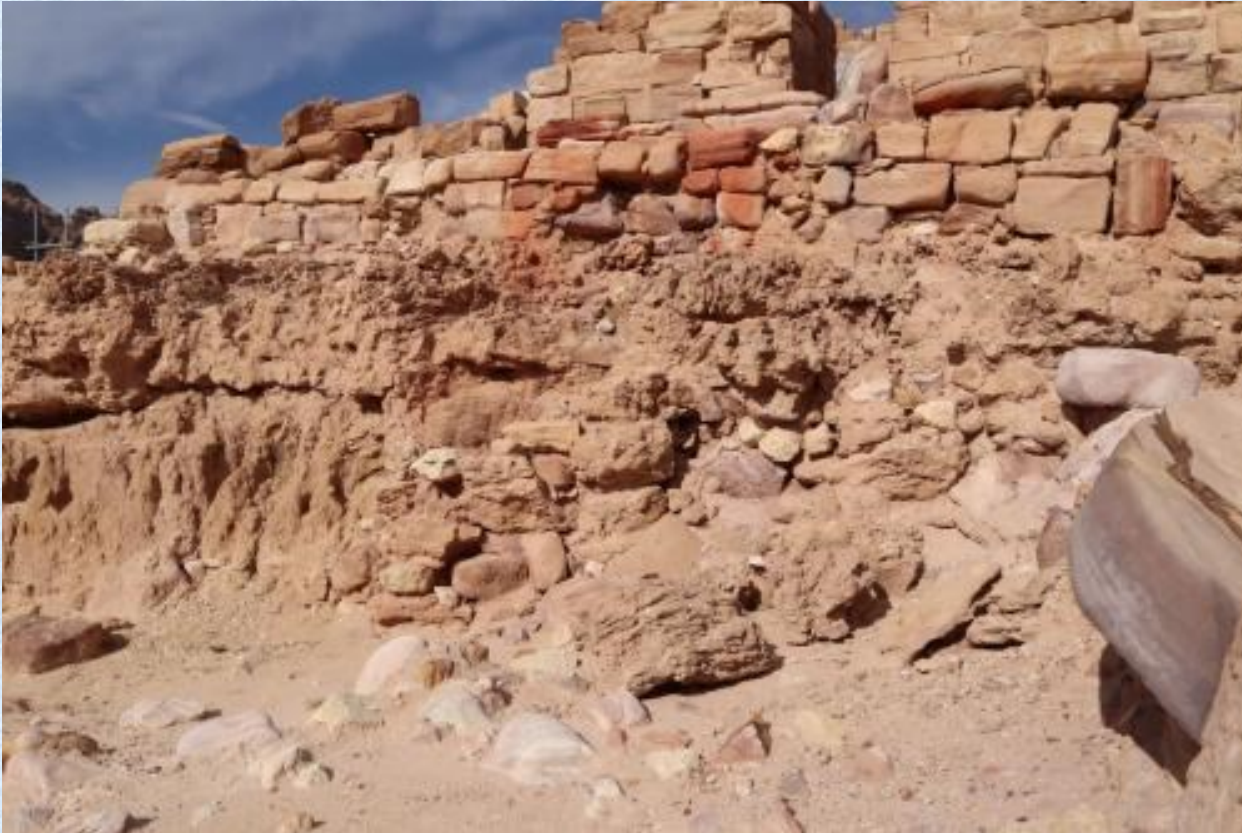
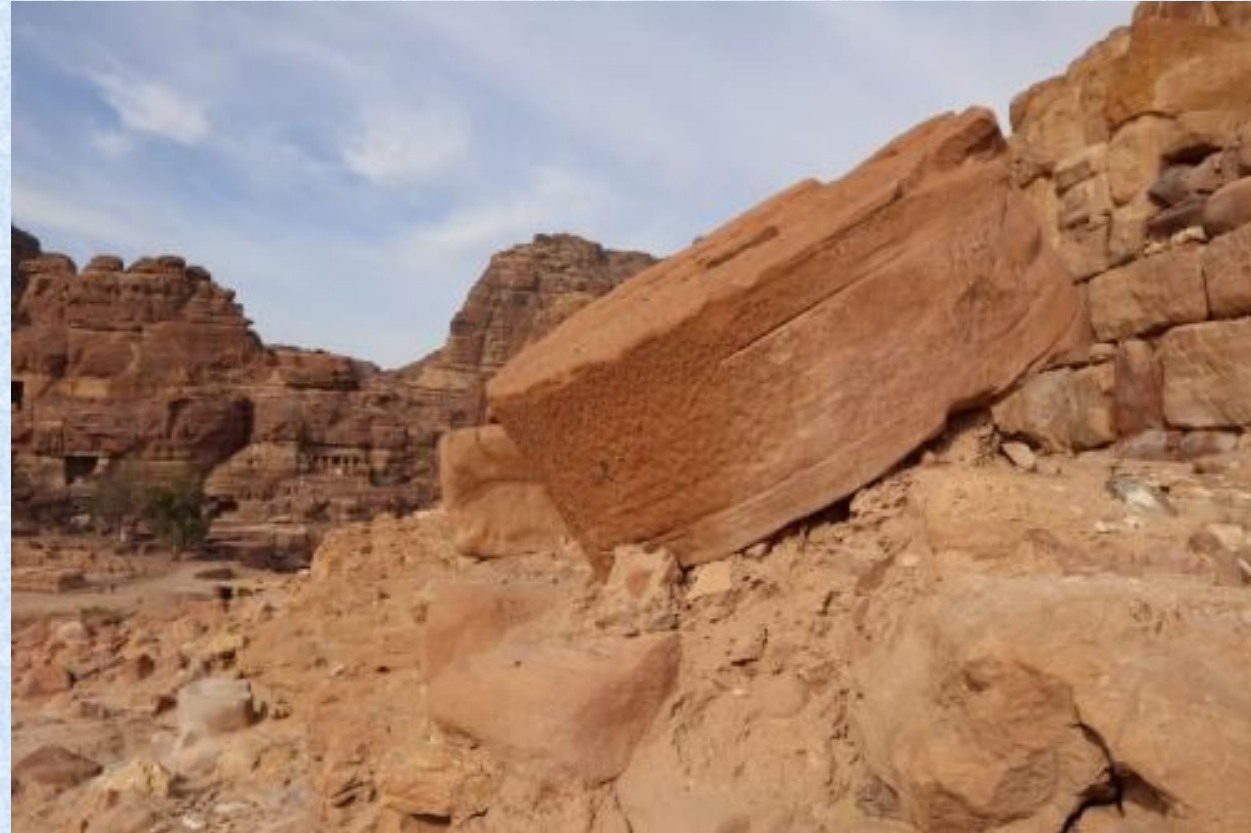
## Survey Dec. 2018 (S wall)

- ✓ Inclination southward
- ✓ Overload by backfilled soil
- ✓ Salts and mechanical degradation of blocks

- ✓ Stability analysis on present conditions of the wall
- ✓ Reduction of the backfilling level
- ✓ Rehabilitation of sandbags buttress

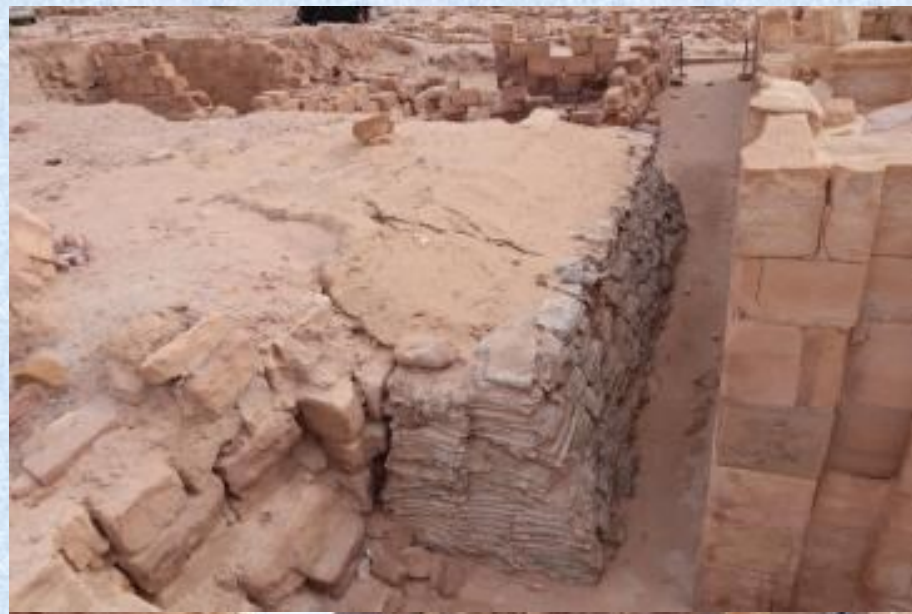
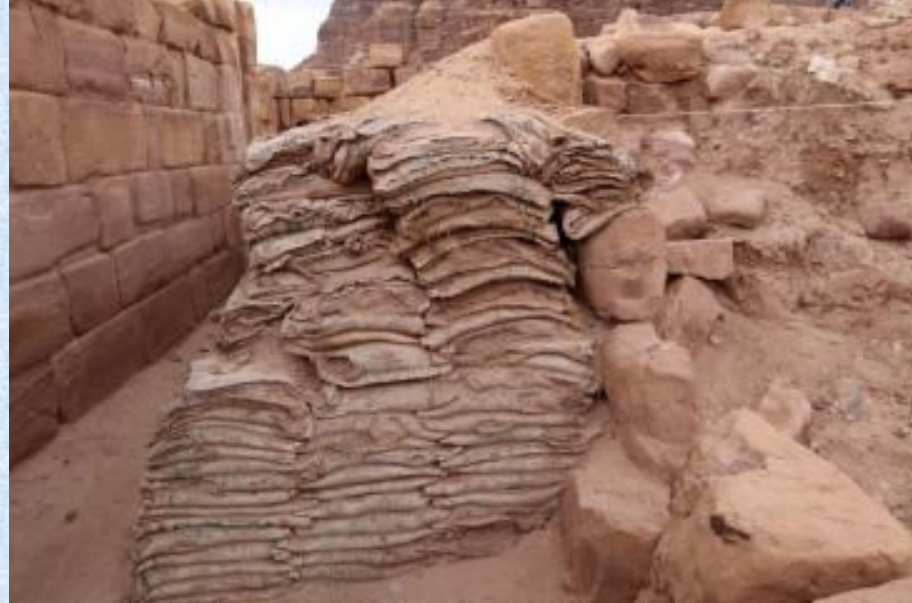
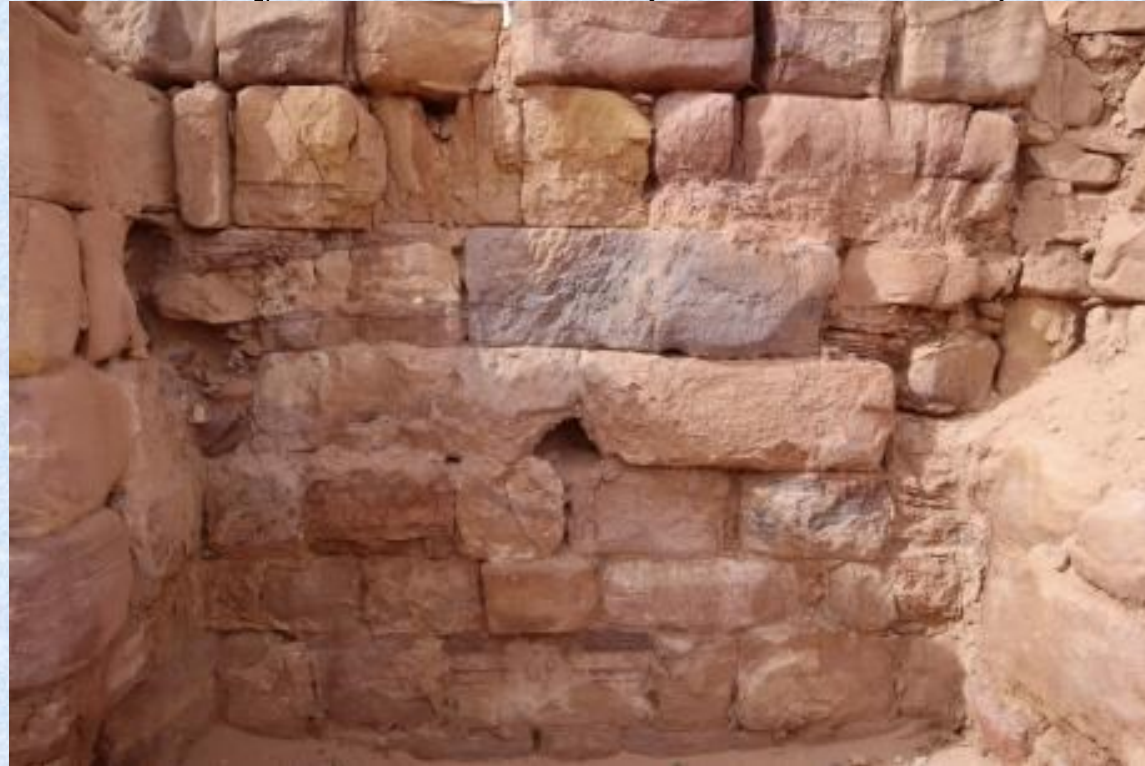
## Survey Dec. 2018 (N corridor, unstable wall)

- ✓ Inclination southward
- ✓ Overload by backfilled soil
- ✓ Salts and mechanical degradation of blocks

- ✓ Stability analysis on present conditions of the wall
- ✓ Reduction of the backfilling level
- ✓ Rehabilitation of sandbags buttress
- ✓ Drainage

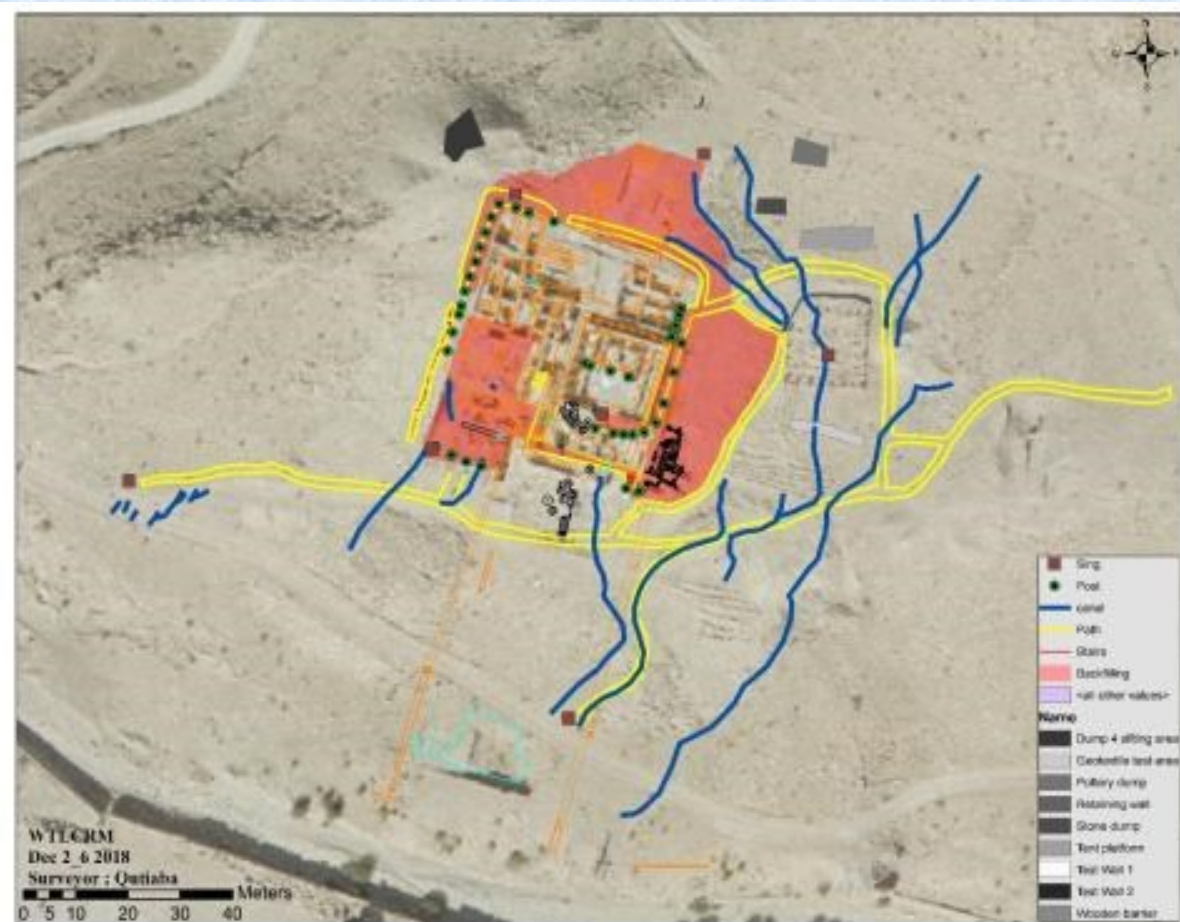
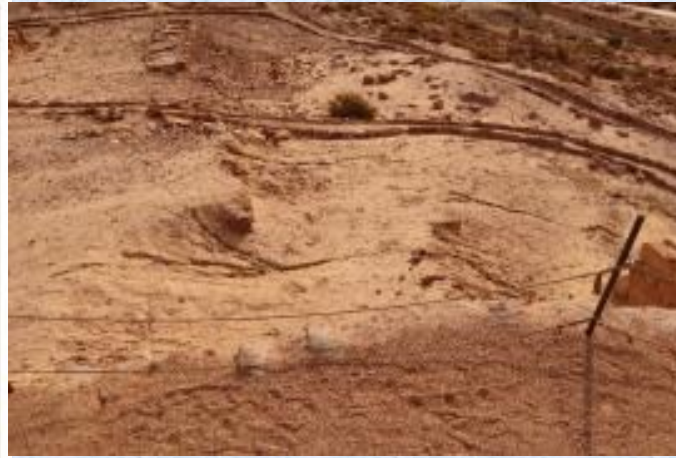
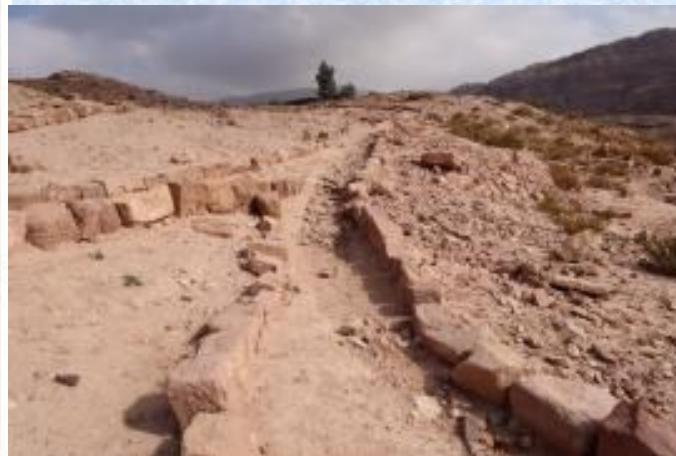
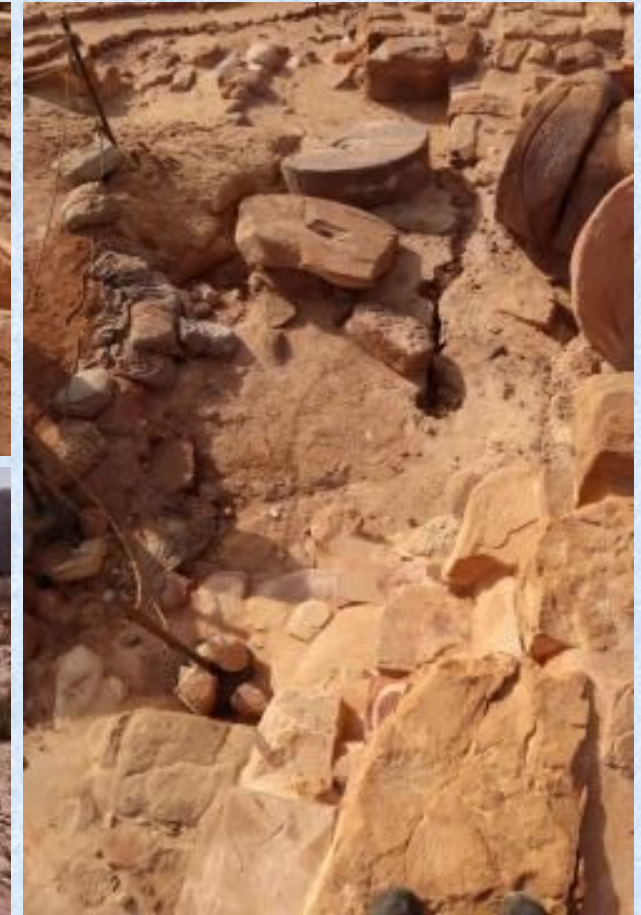
# Survey Dec. 2018 (Drainage conditions TWL area)

- ✓ Erosion of backfilled areas
- ✓ Effects of paths on water run-off

- ✓ Documentation of erosion forms and drainage
- ✓ Channelling
- ✓ New design and planning of paths

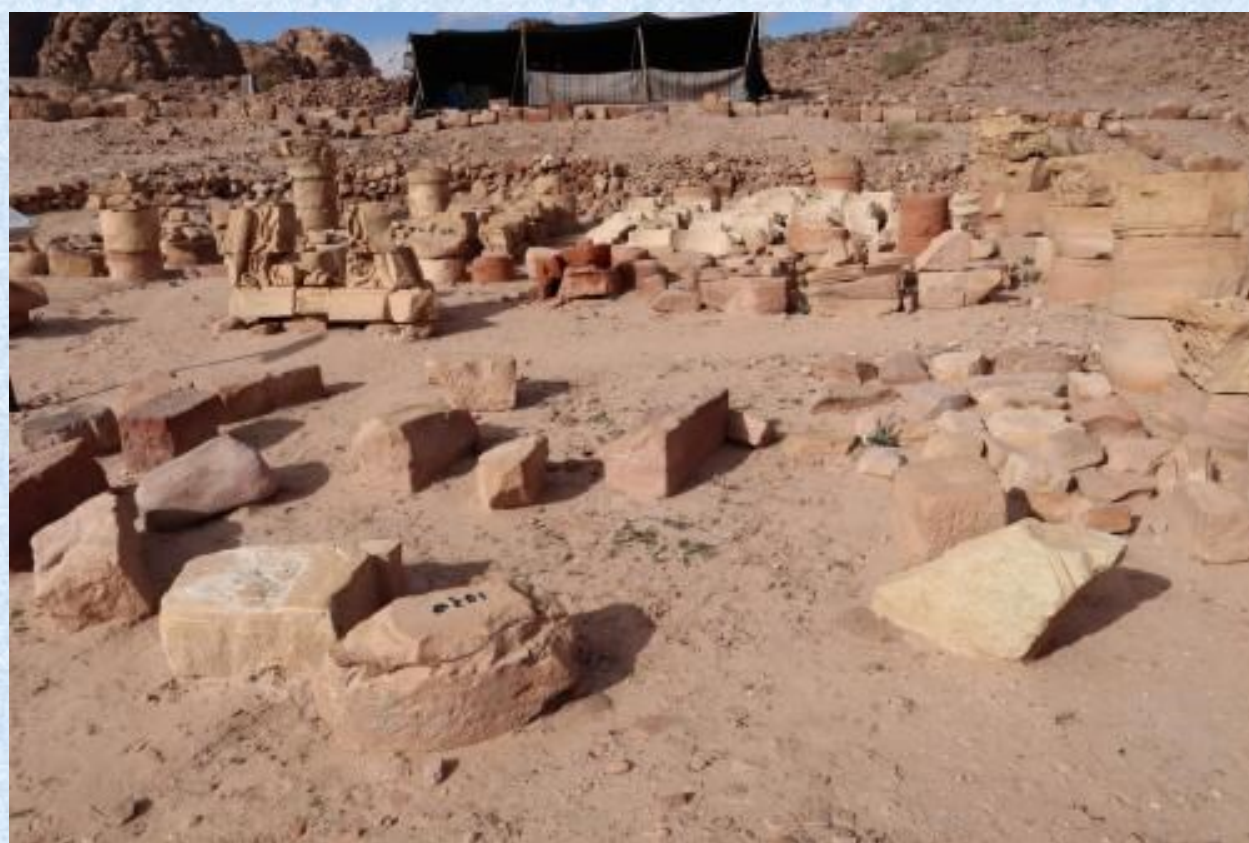
# Survey Dec. 2018 (Lapidarium assessment)

- ✓ Erosion/weathering of the artifacts
- ✓ Water run-off in the area

- ✓ Analysis of weathering vs. typology of materials
- ✓ New design of the Lapidarium area
- ✓ Placement of artifacts on a platform
- ✓ Construction of dry wall (landscaping)
- ✓ Drainage

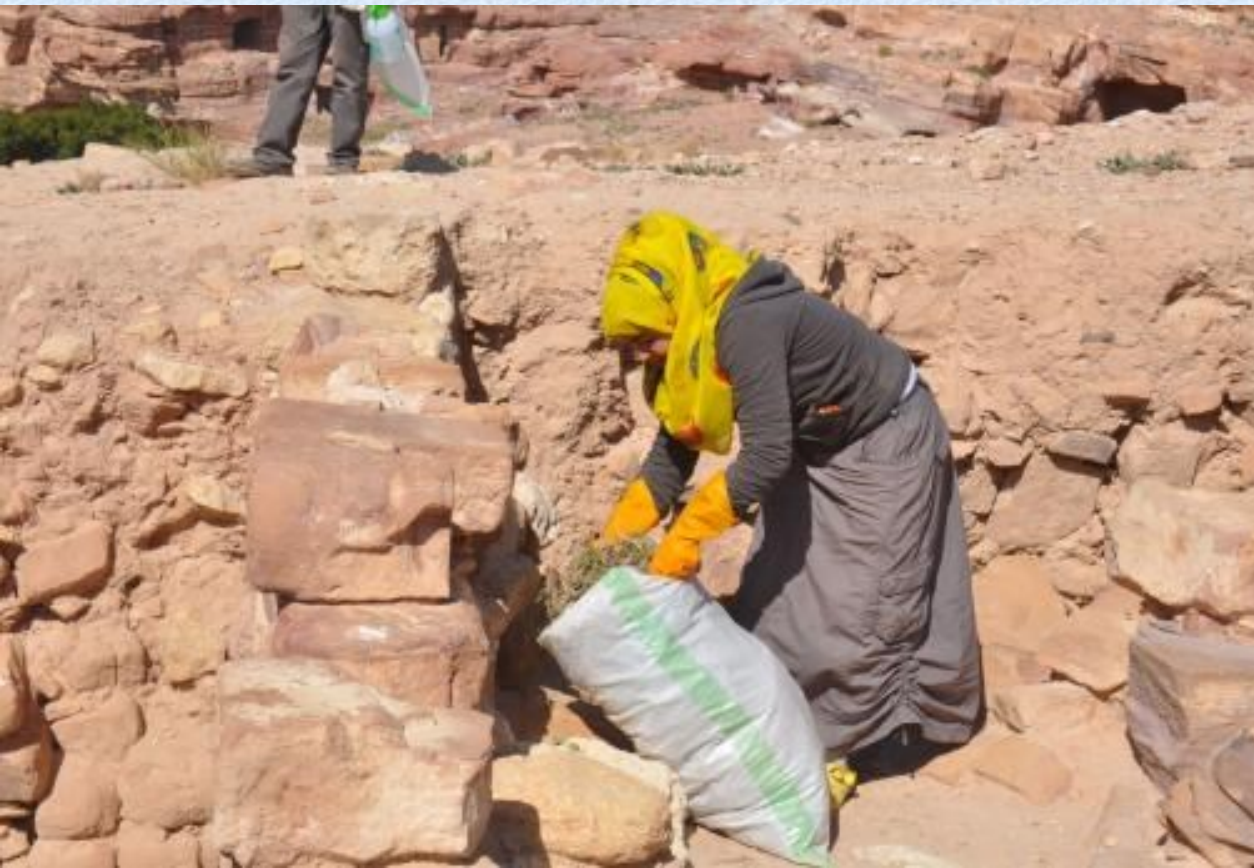
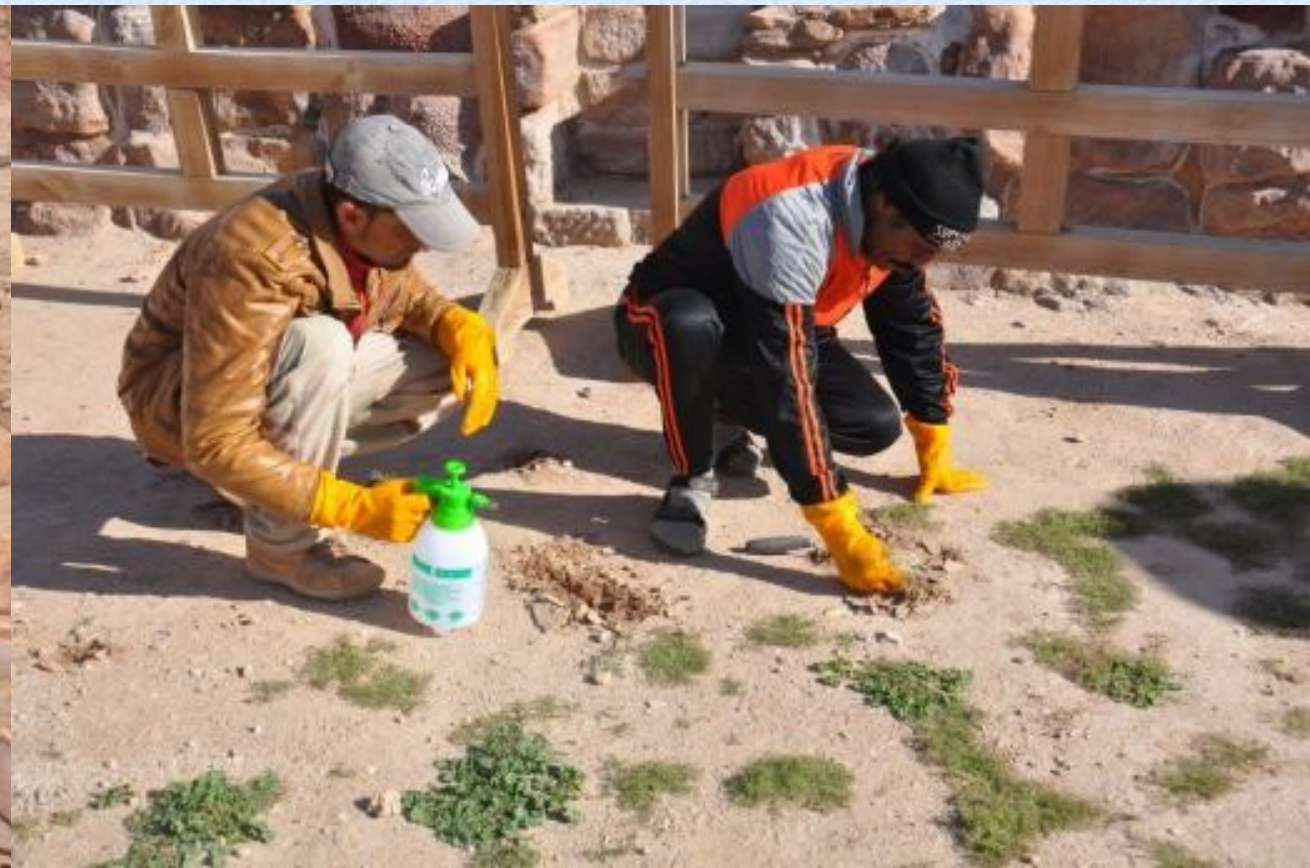
# Herbicide and removal of plants

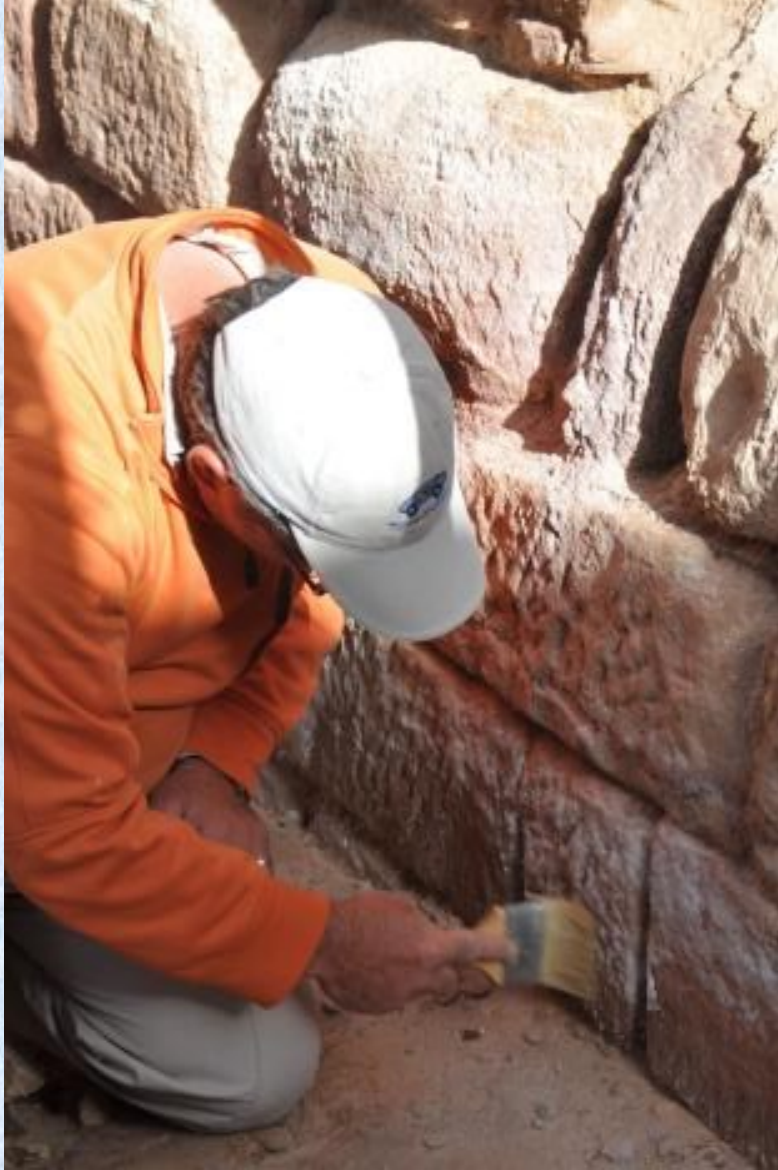
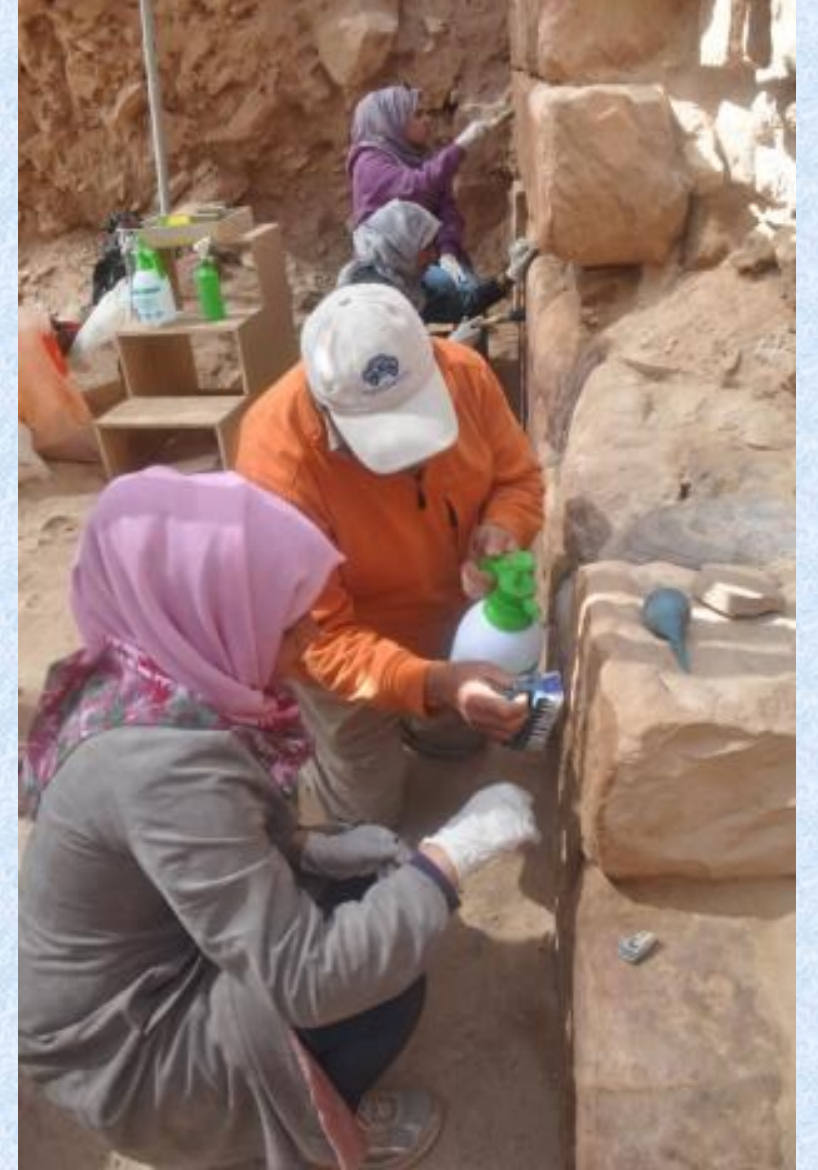
# Salts Removal

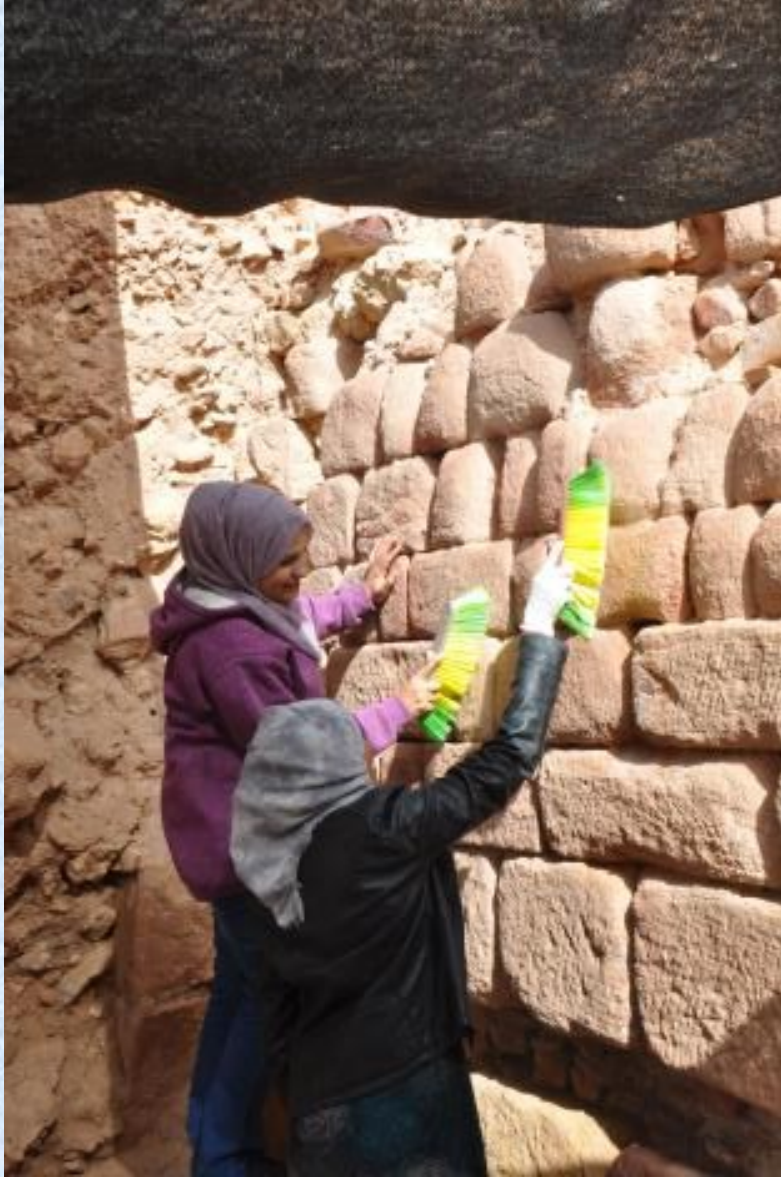
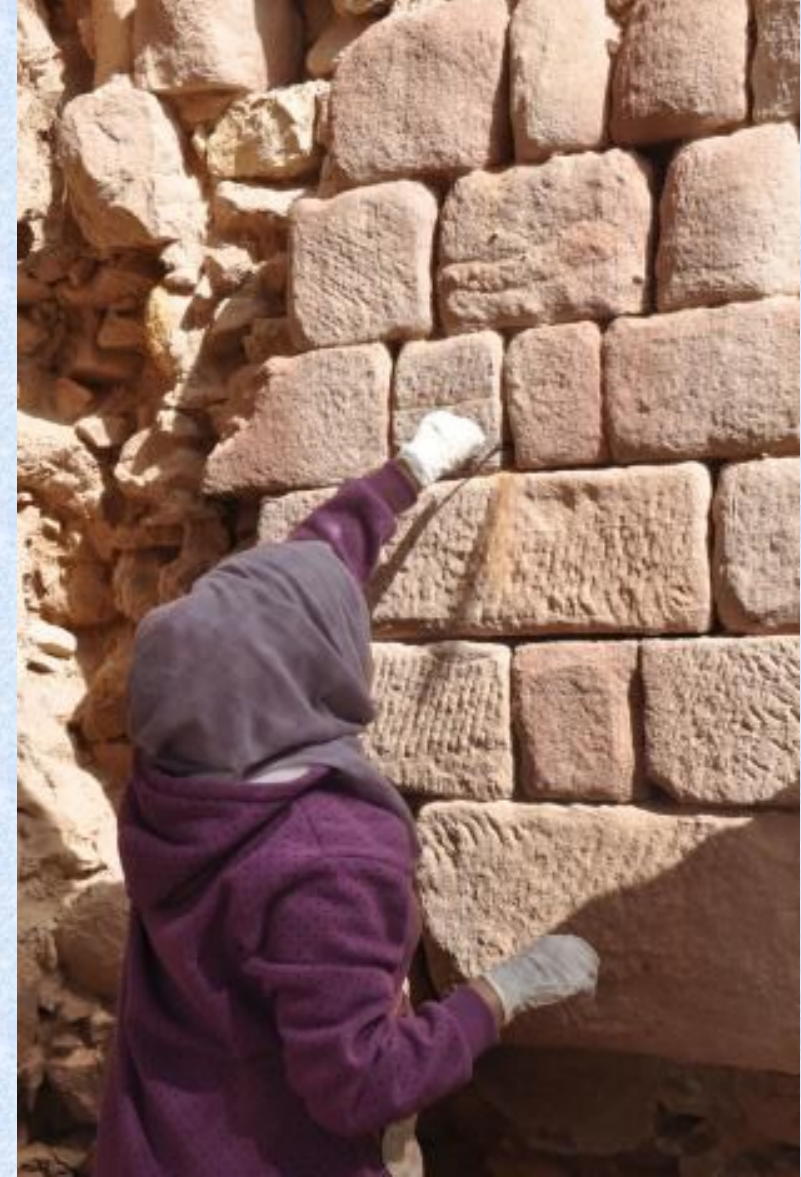
# Cleaning and removal of unstable soil

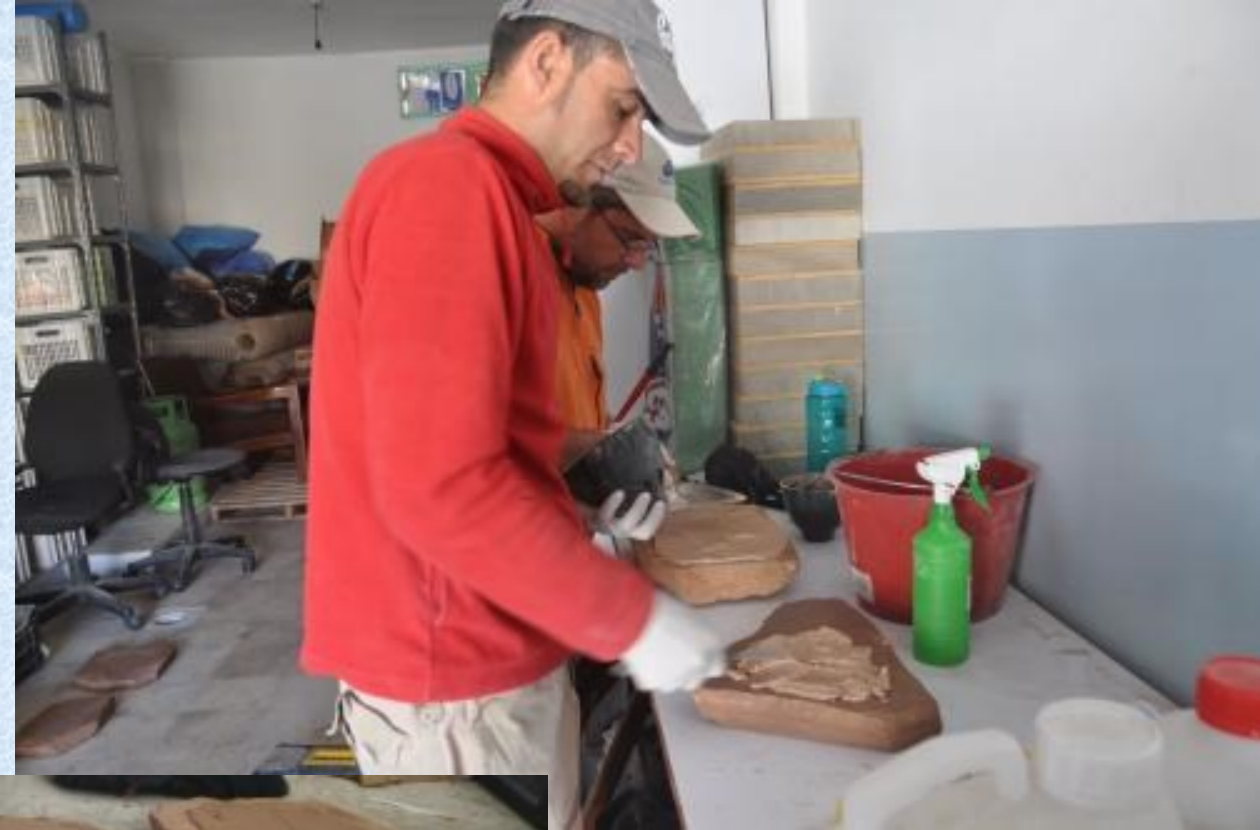
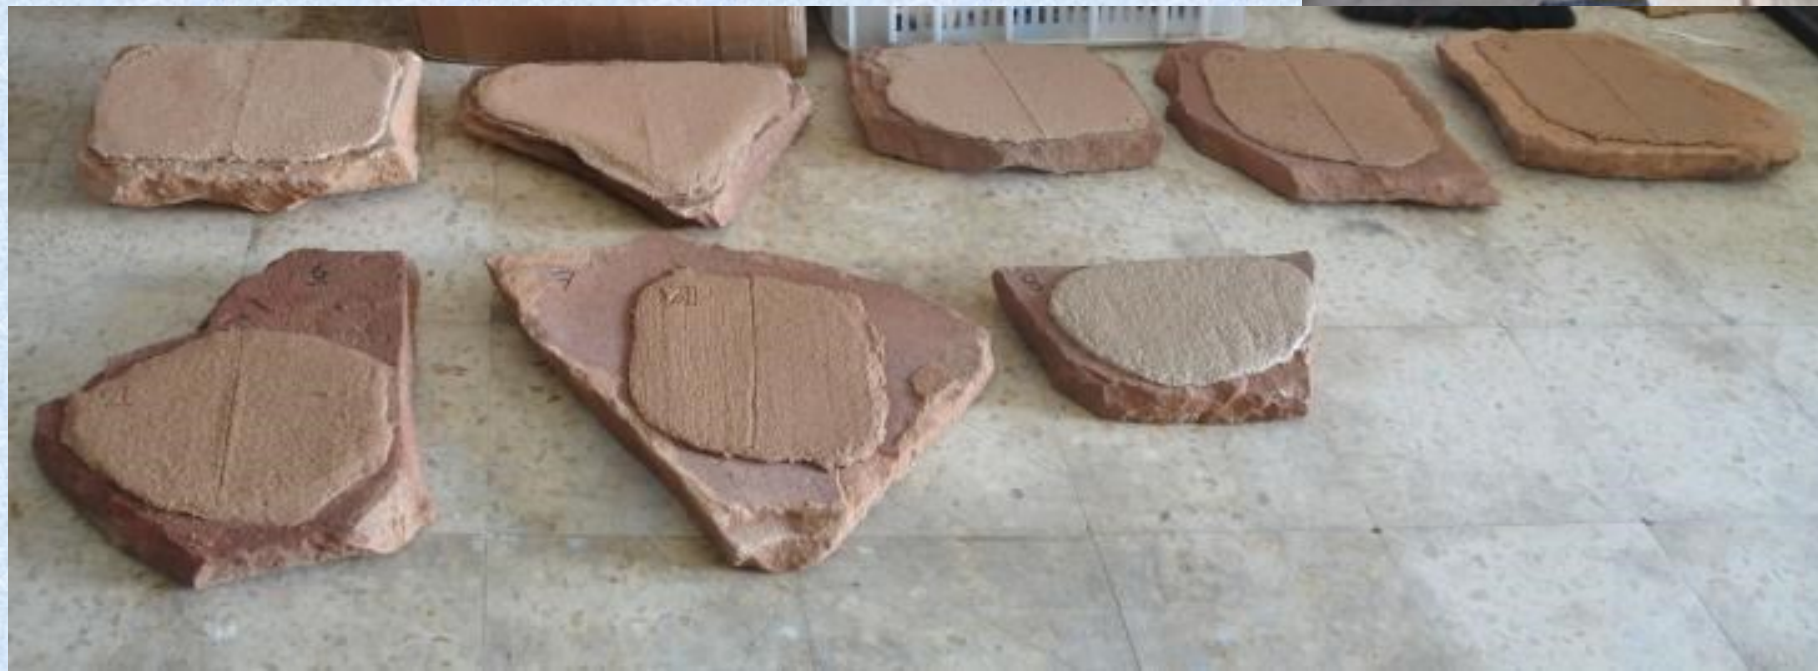
# Base-Lime Mortar Test with different Lime (Hydrated and Hydraulic) and different aggregates

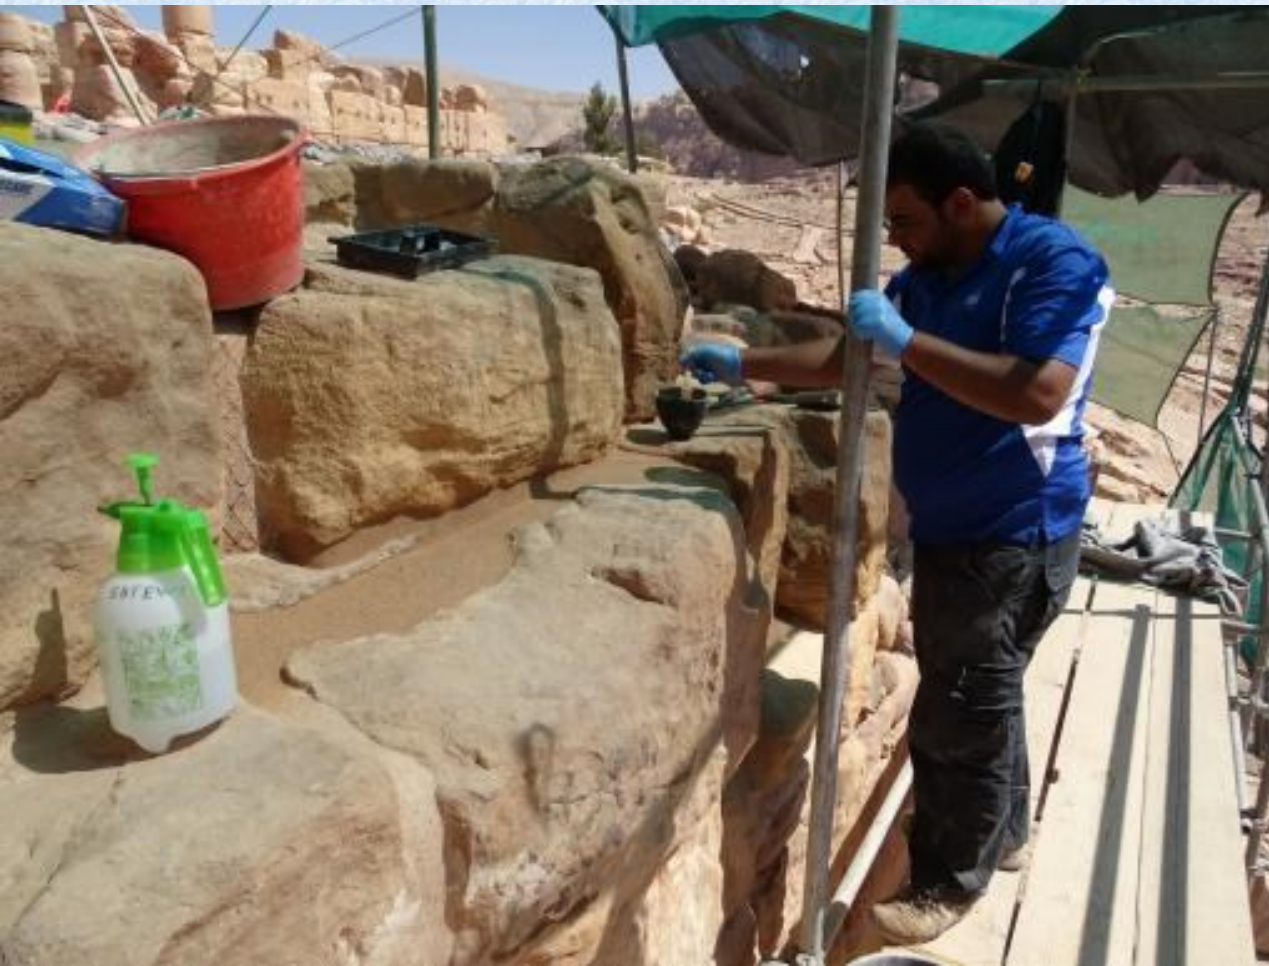
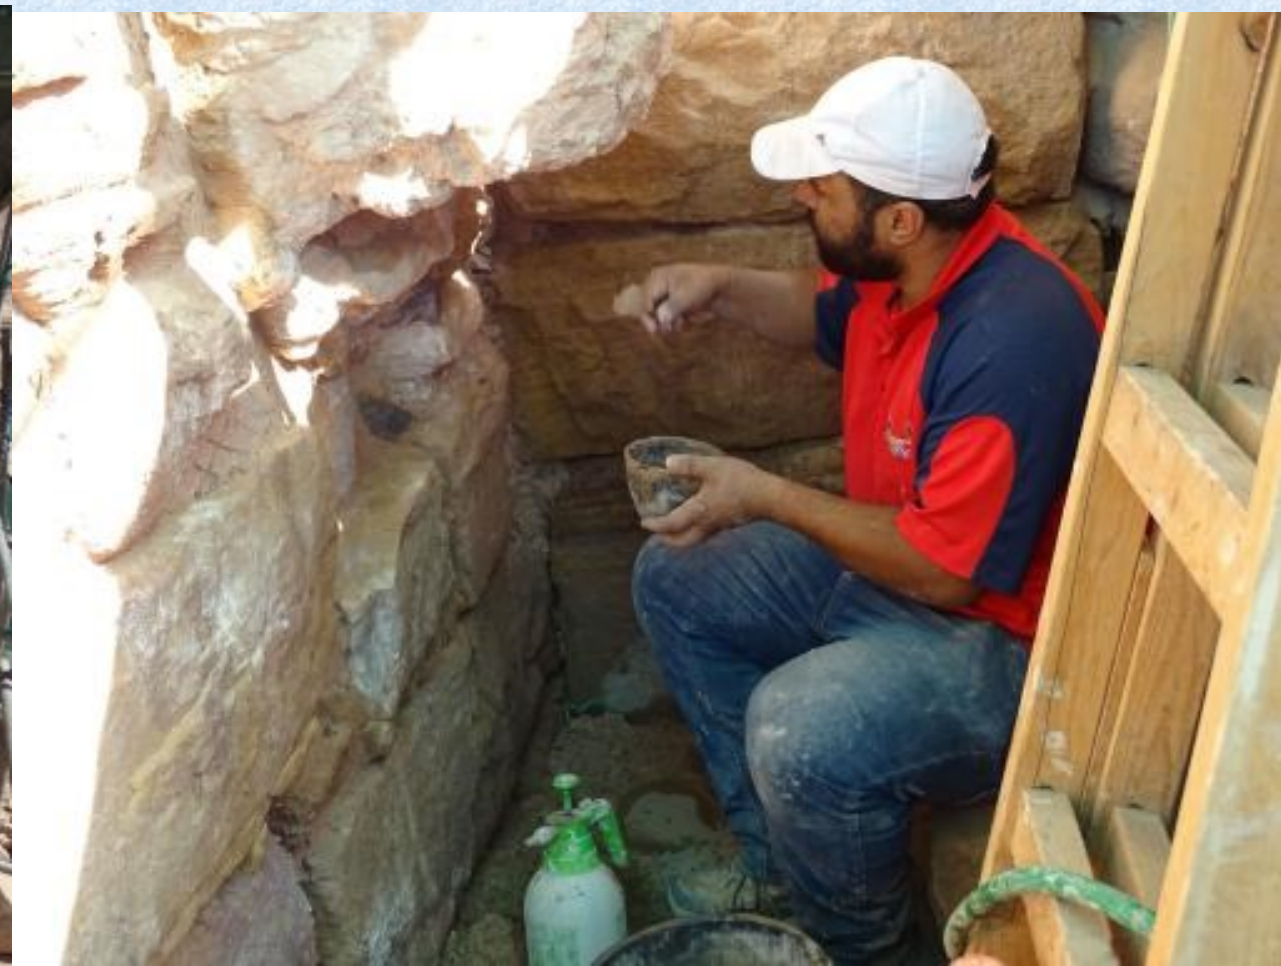
# Applying Mortar

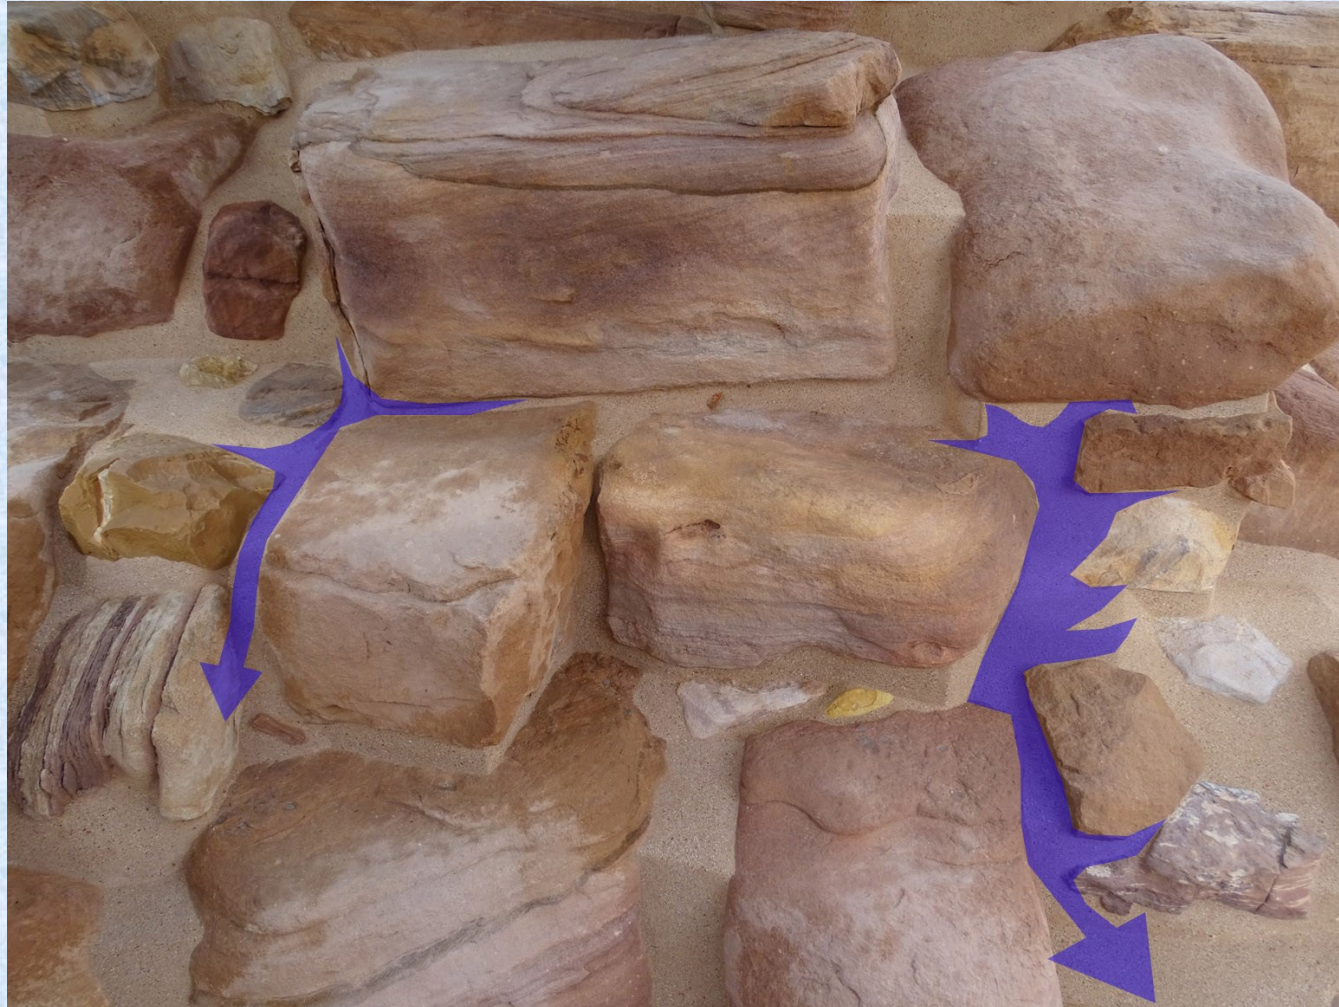
# Grouting joints with inclination for evacuating rainwater

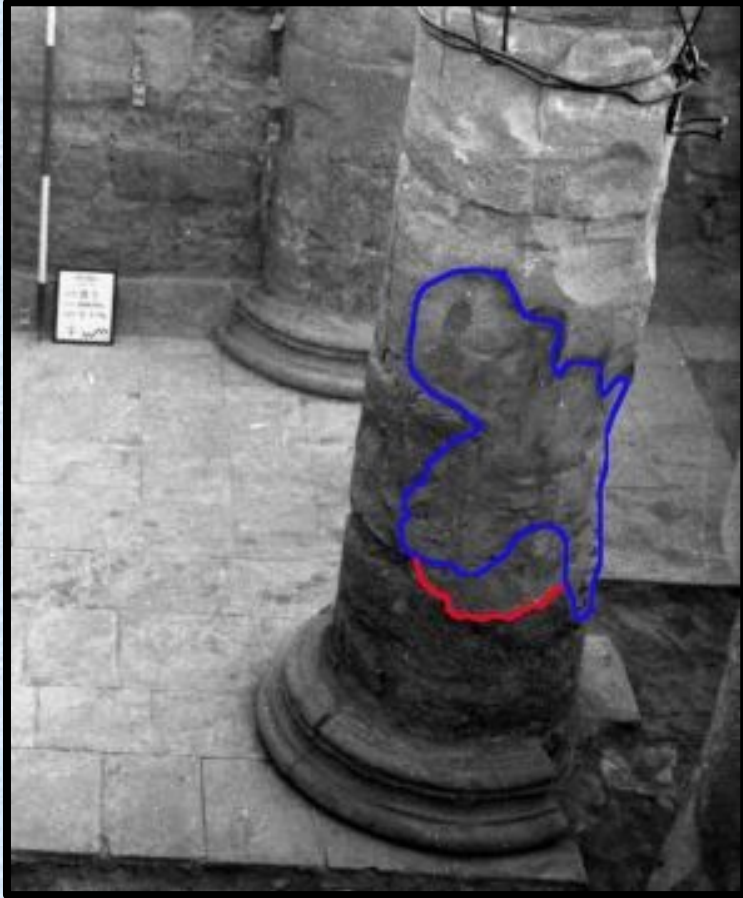
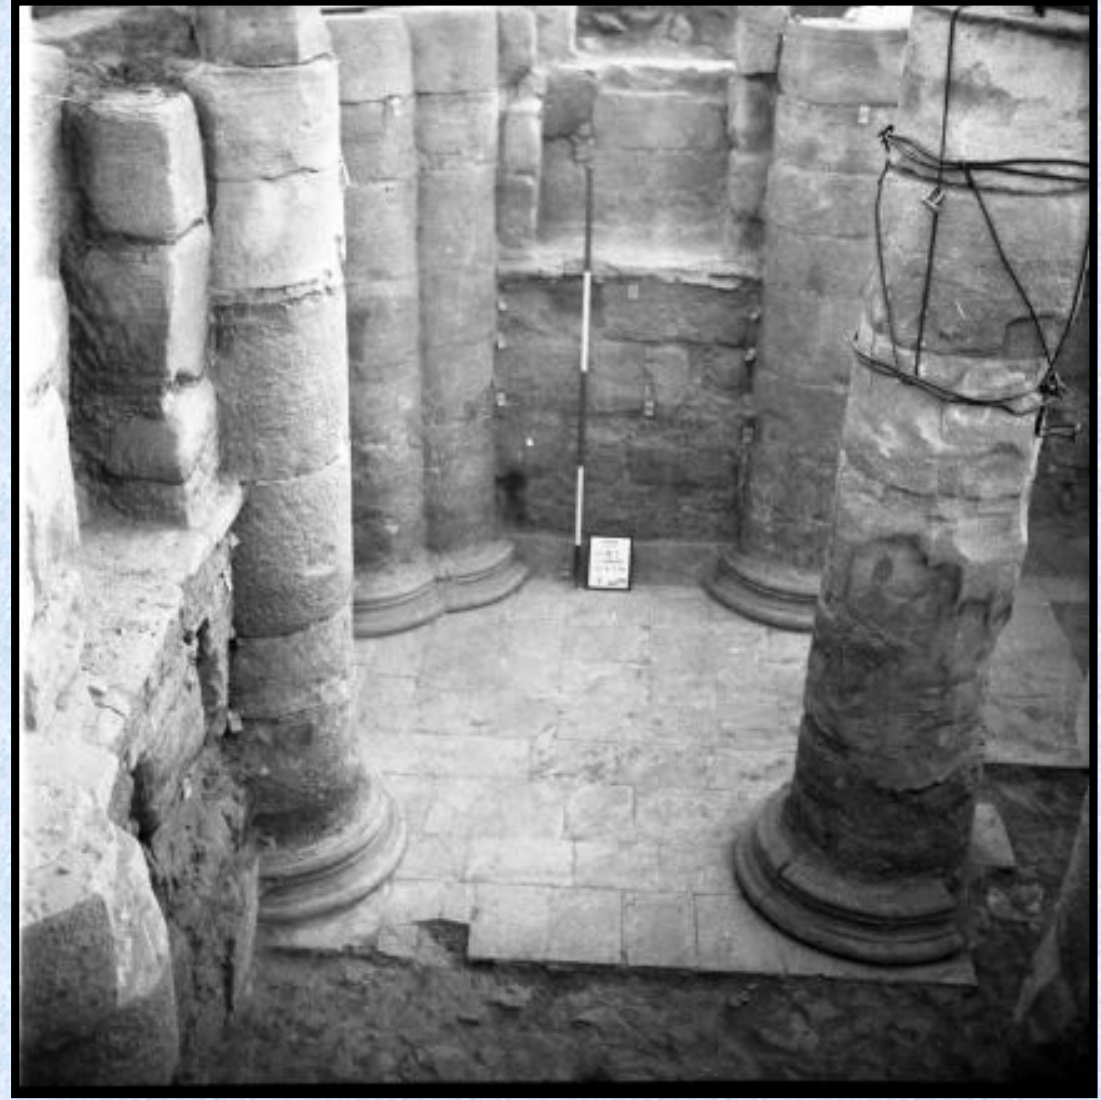
# Photo of the excavation with obvious problems of deterioration
