**FRANCO SCIORILLI**

**A History of Conservation at the Temple of the  
Winged Lions**

**JULY 9 2019**

**Lecture Hall, AL HUSSAIN BIN TALAL UNIVERSITY, Petra College for  
Tourism and Archaeology  
Wadi Musa, Jordan**

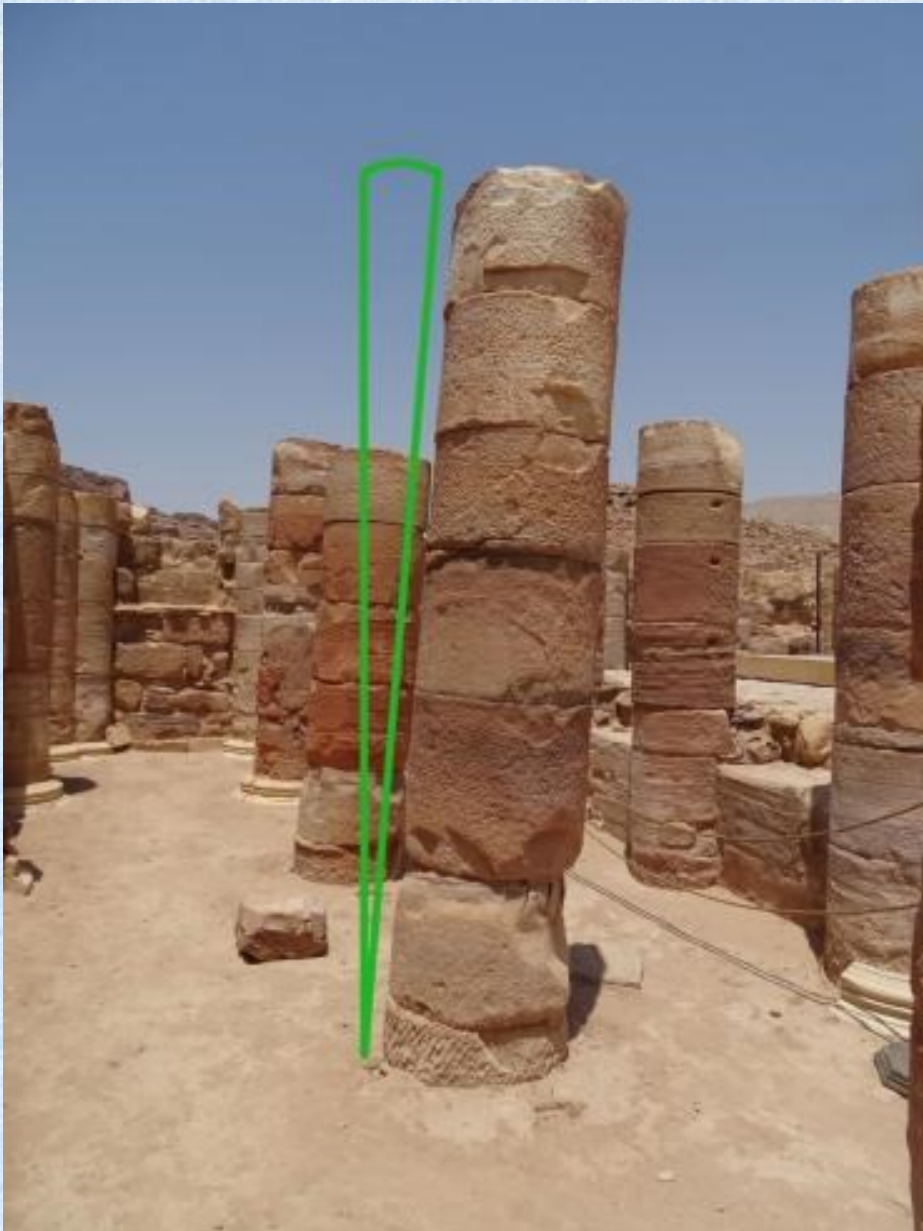
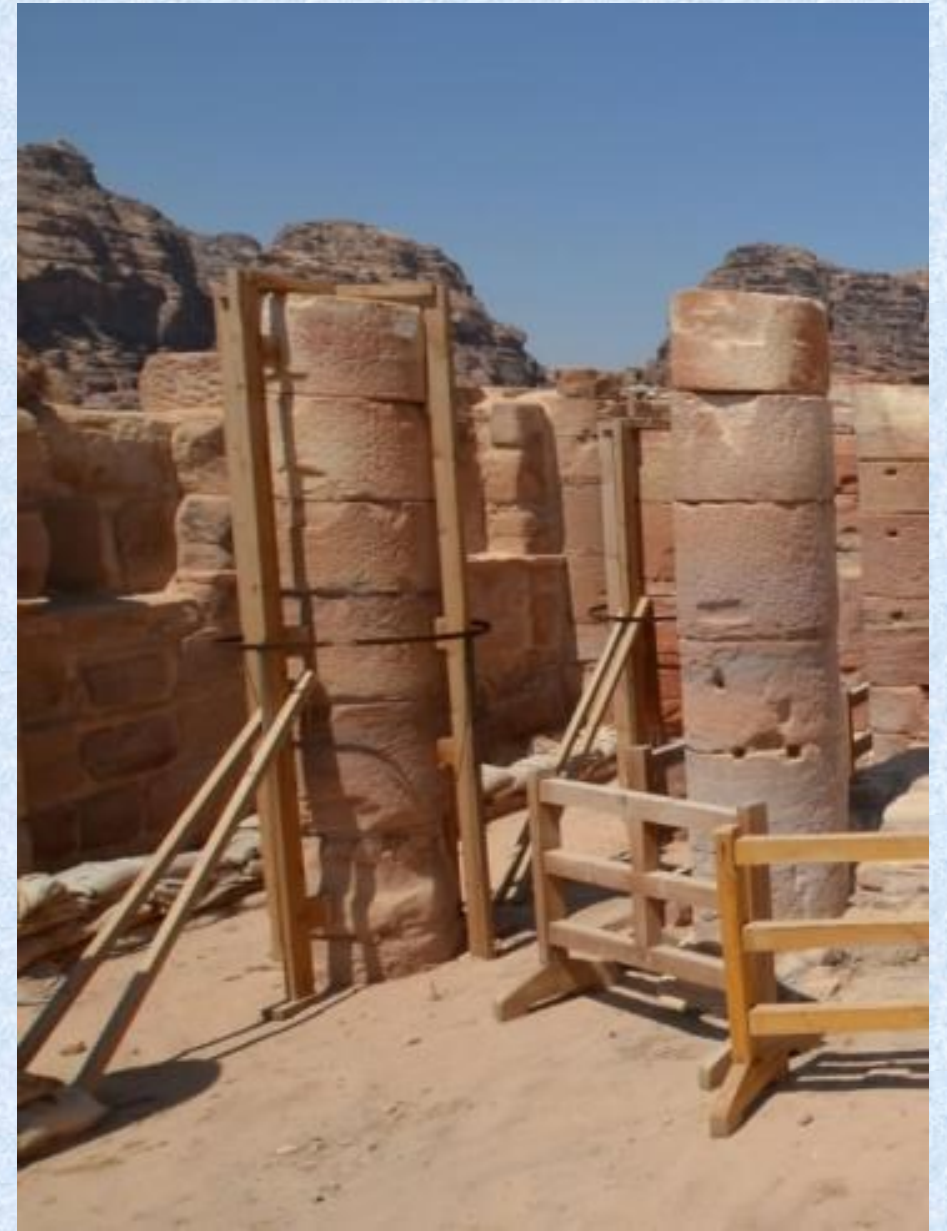
# Tilt of the 3 columns for land subsidence

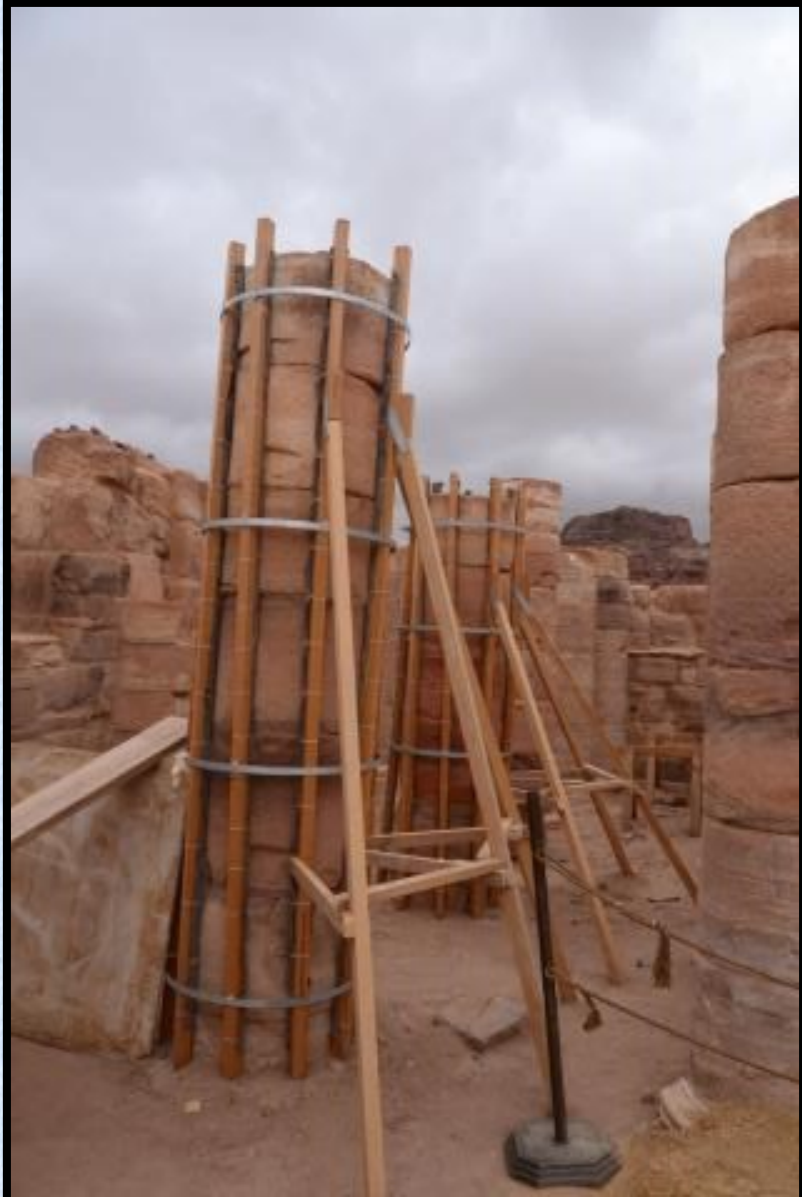
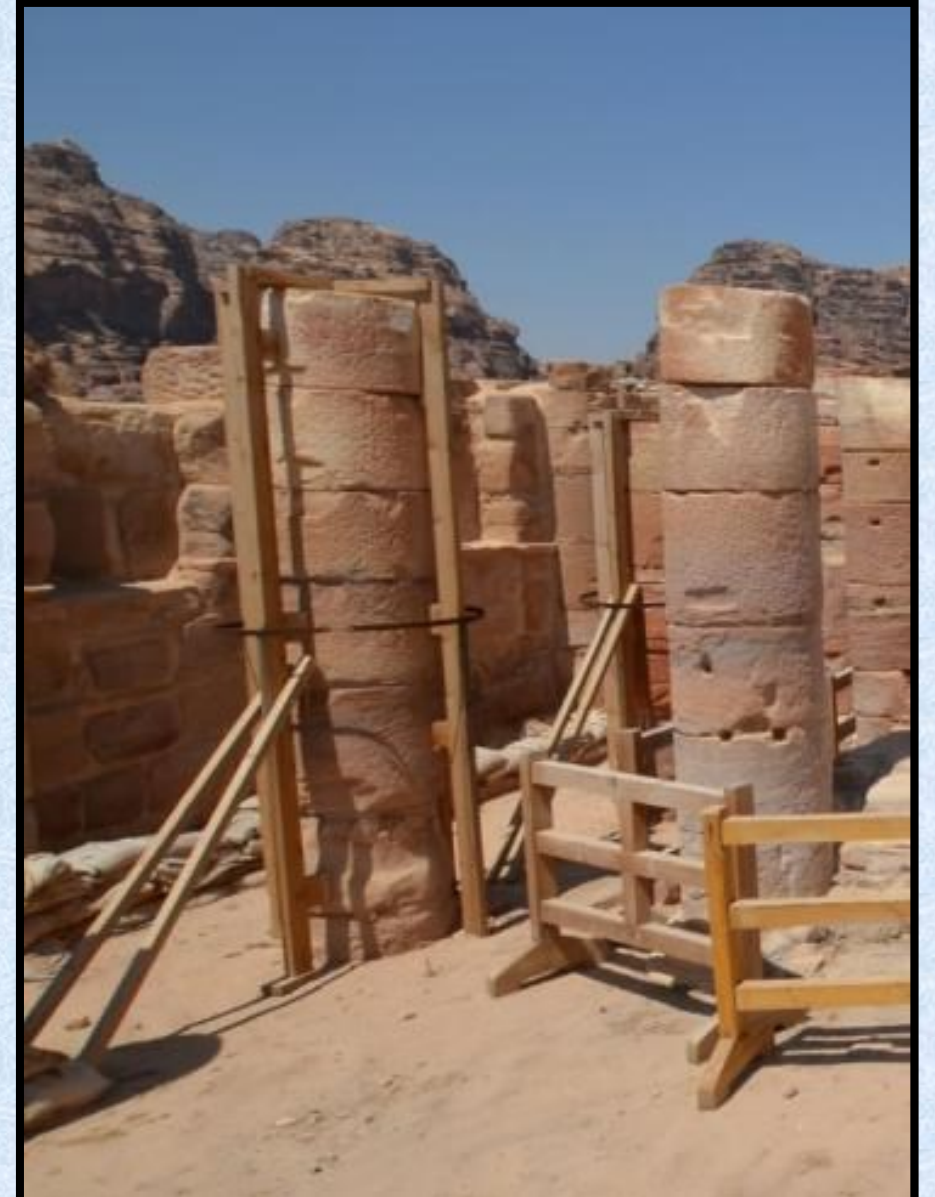
# Harness with wooden posts of columns 32E and 33E

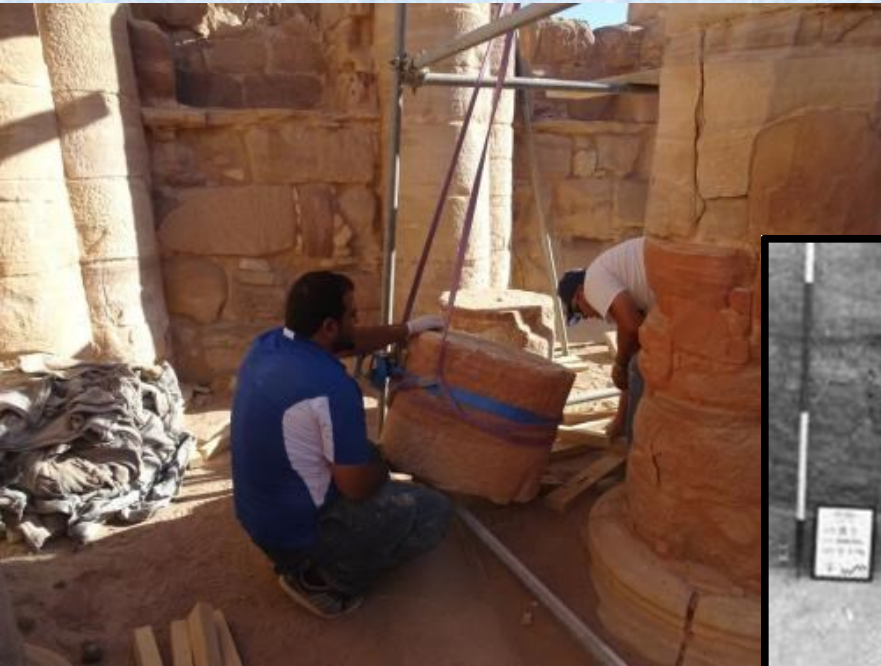
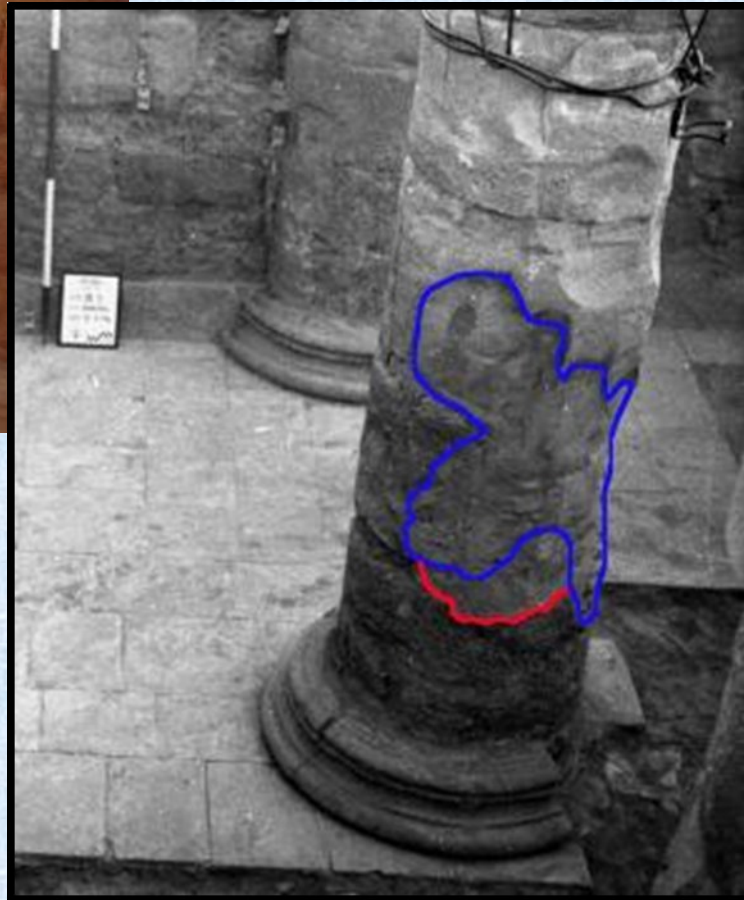
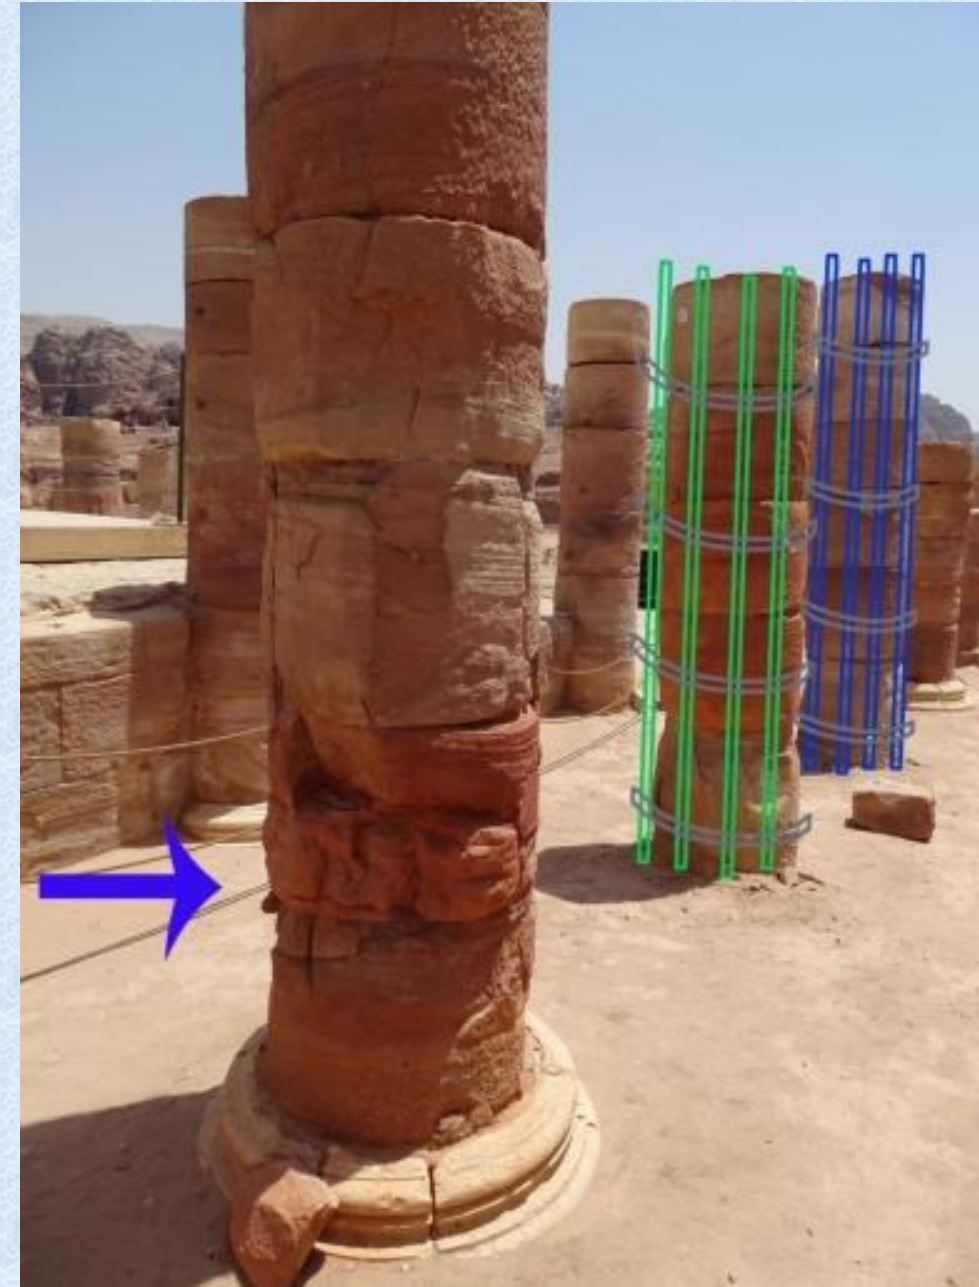
# Replacement of the second drum

# Re-adhesion with Basf epoxy resin

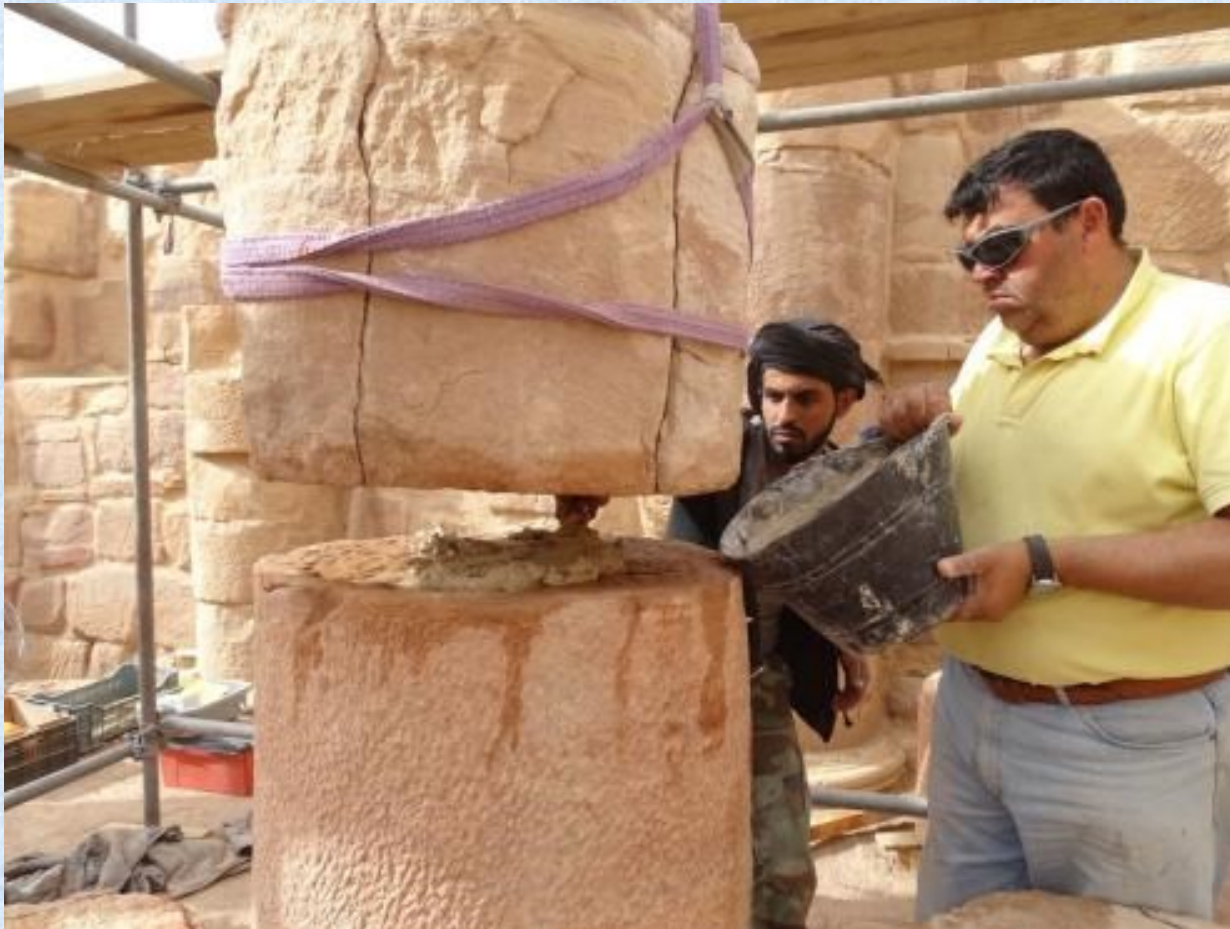
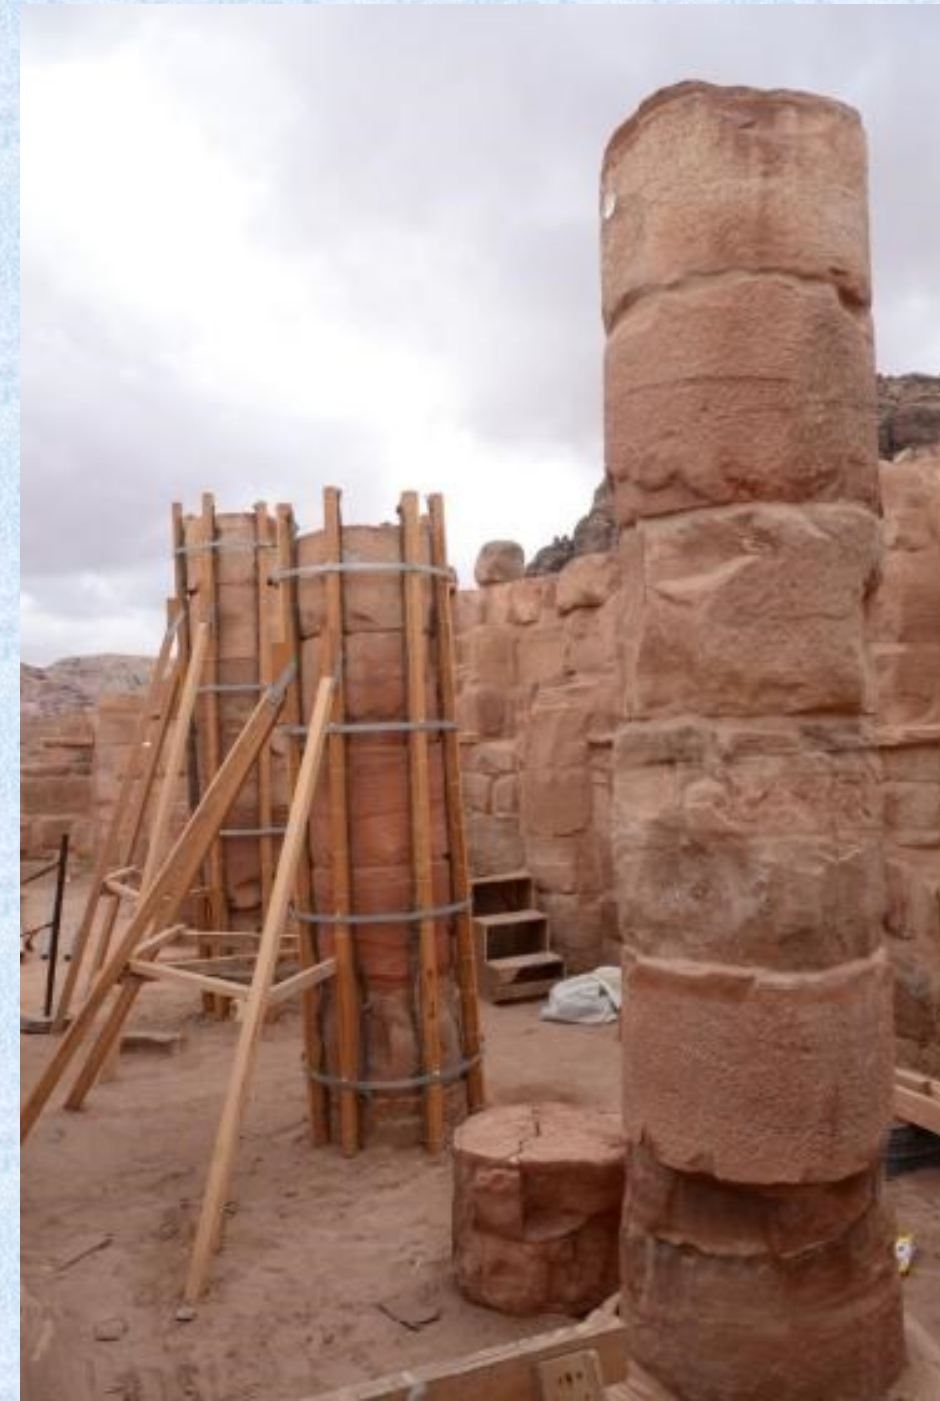
# Repositioning of the column drums

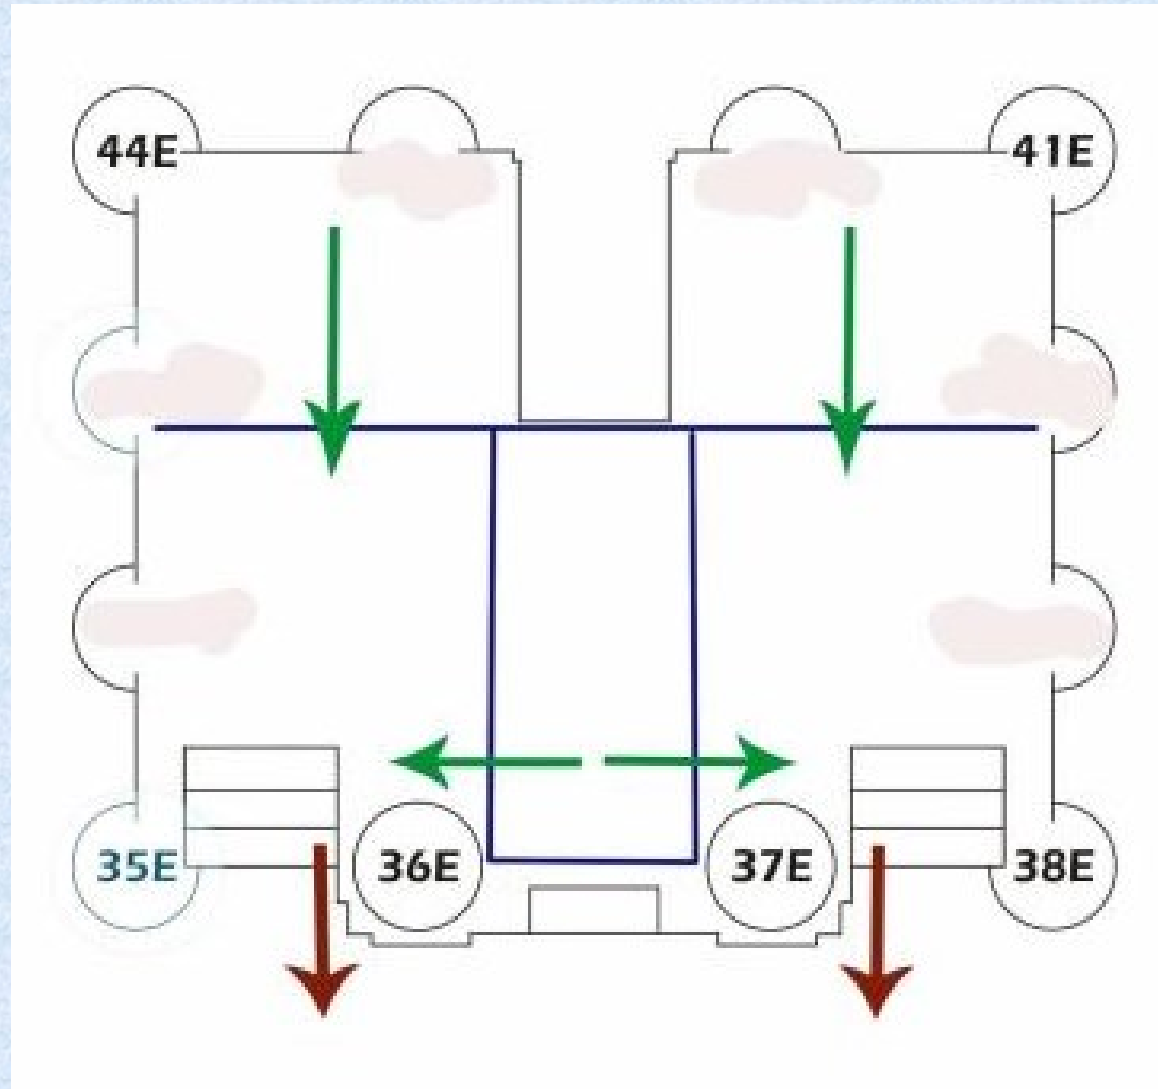
# Evacuation of water from the Podium

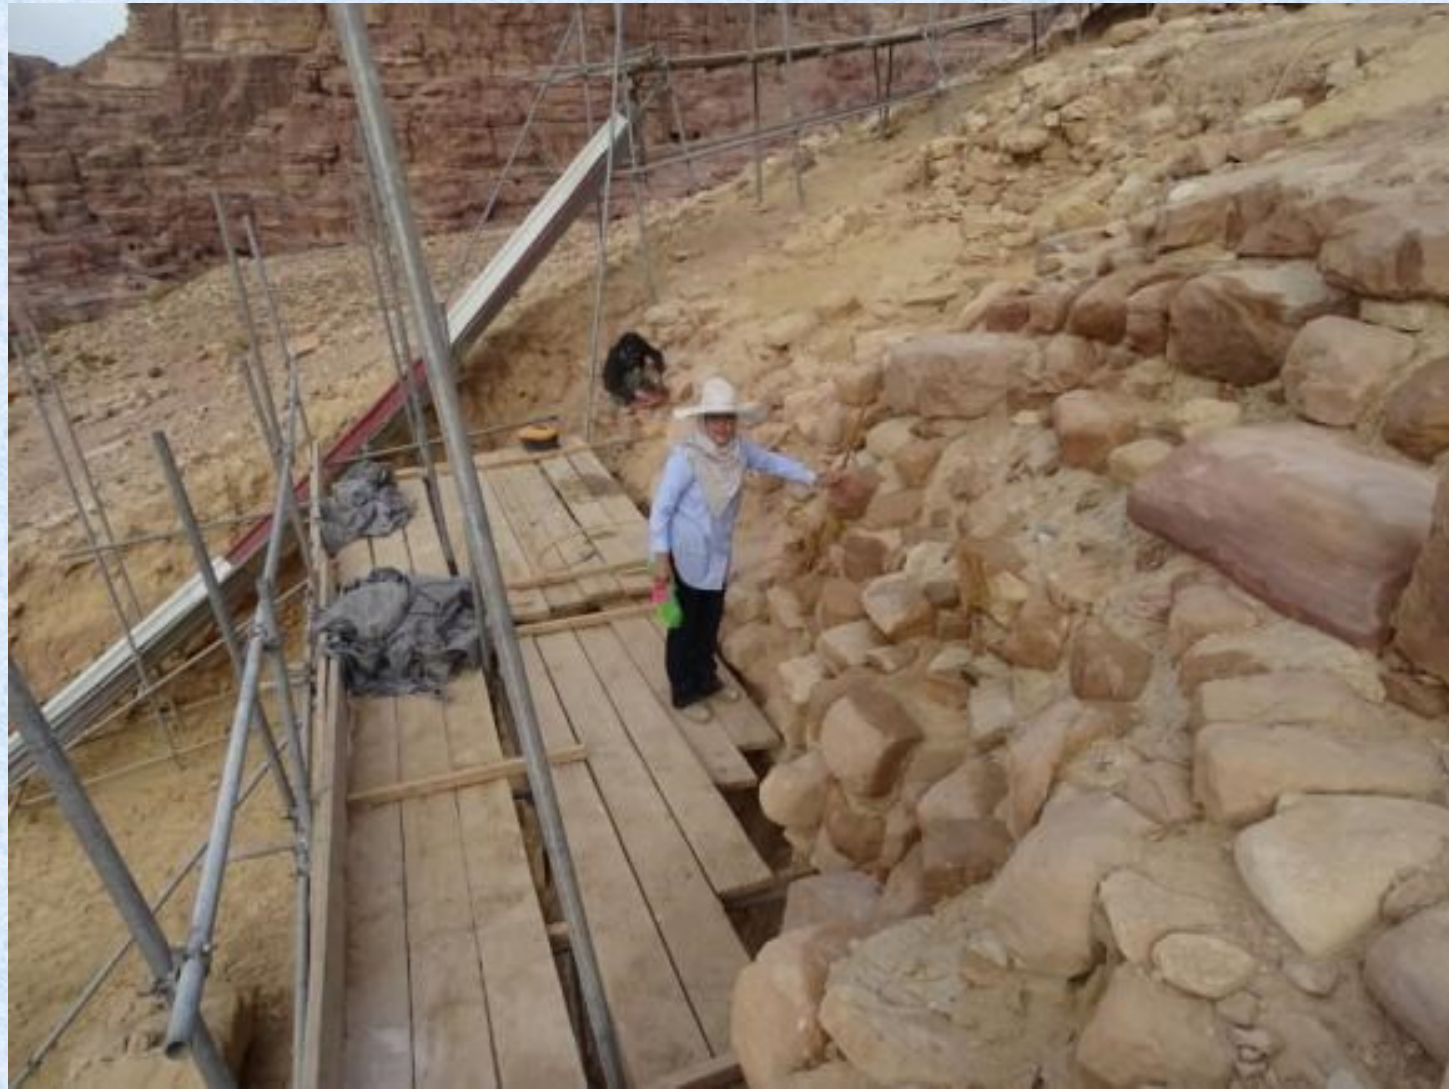
# Cleaning from dust and debris

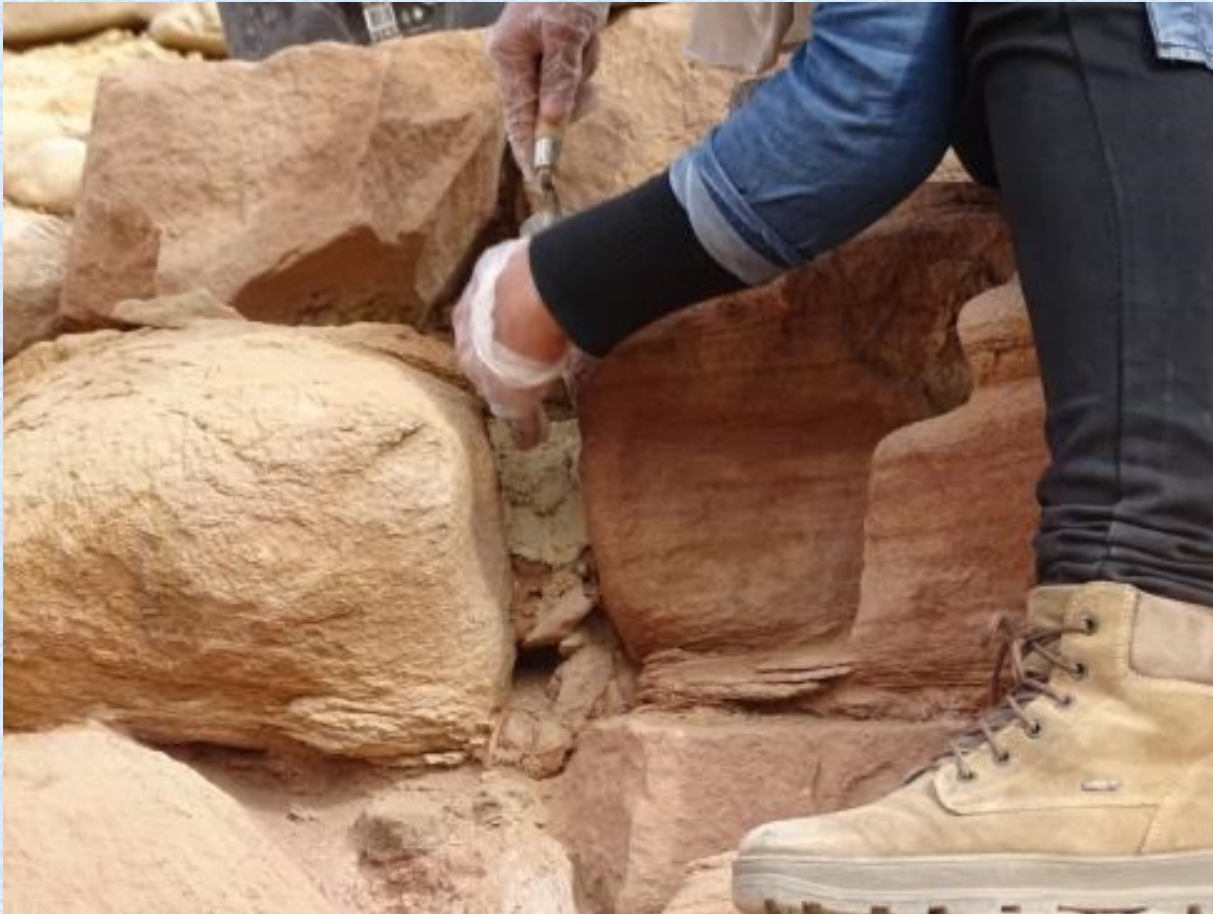
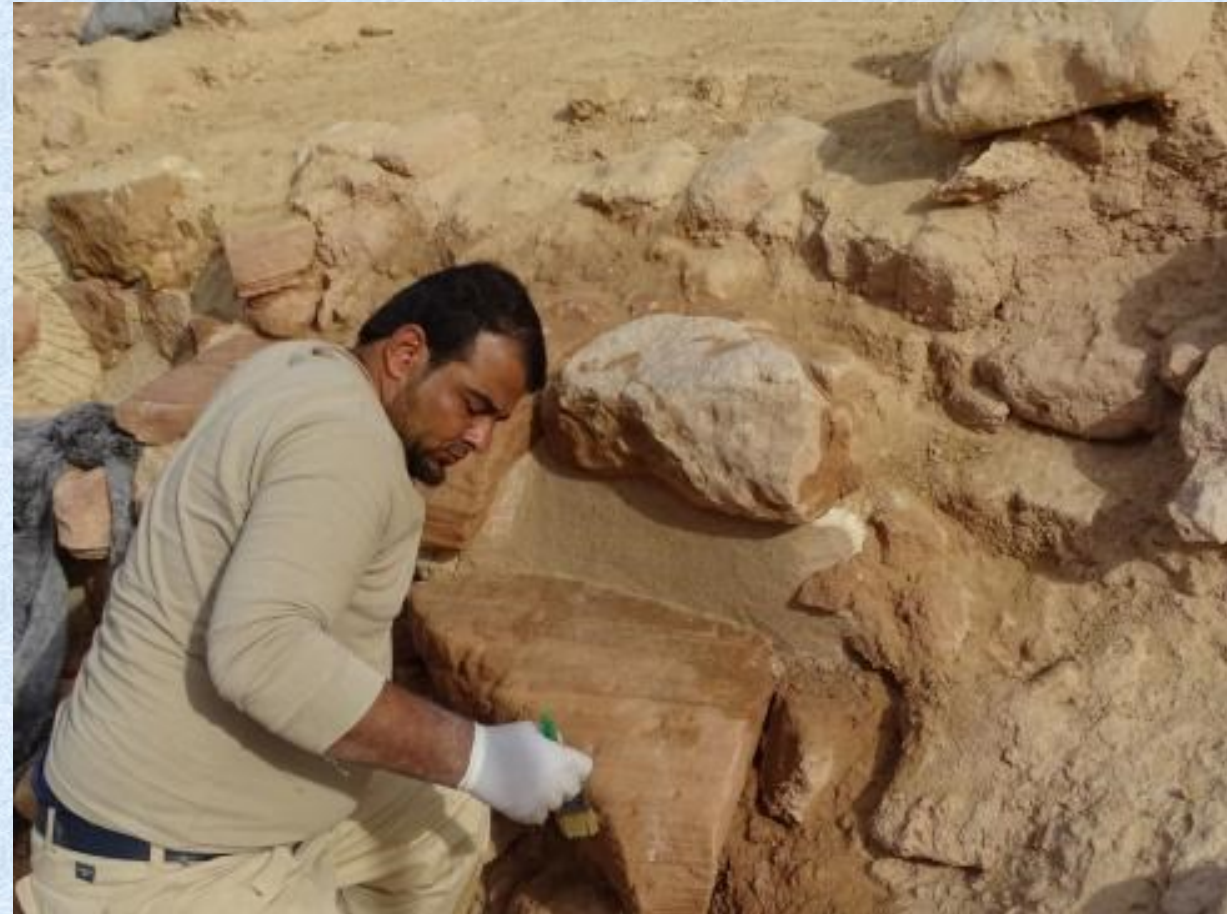
# Depth and Final Lime Base Mortar

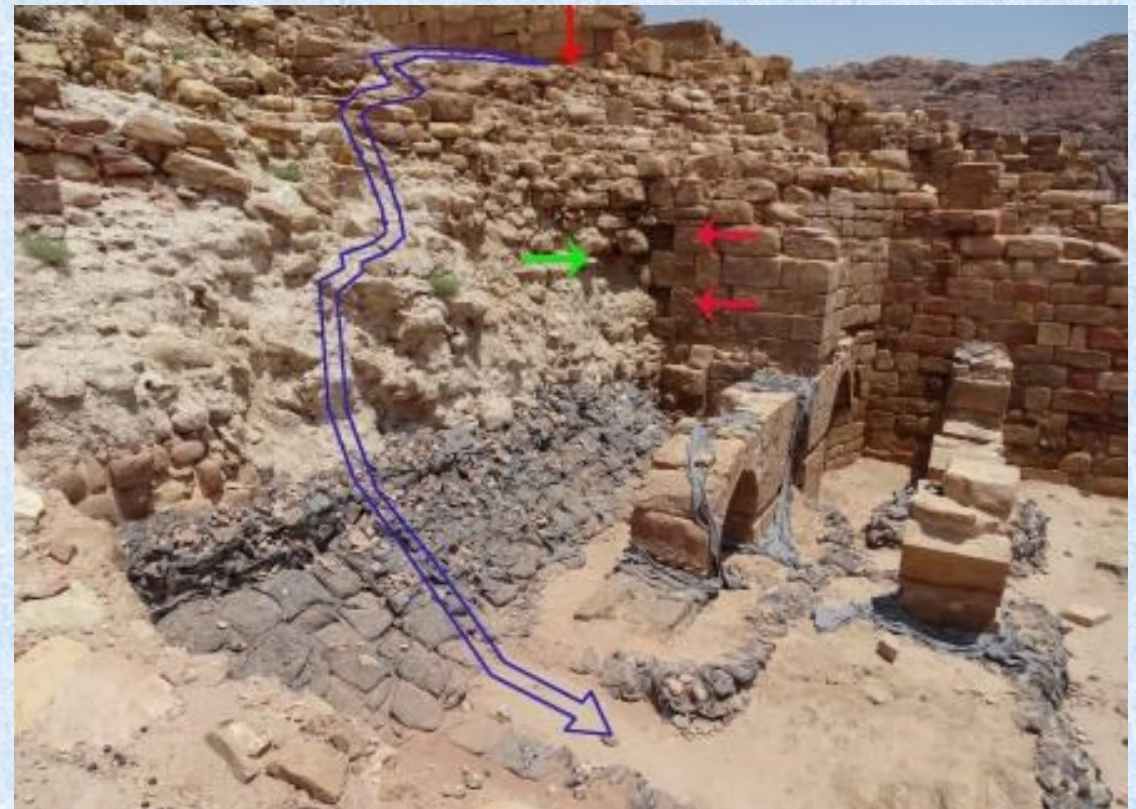
# Details of the problems

1-Drainage channel

2- Support wall

3- Put two stones back

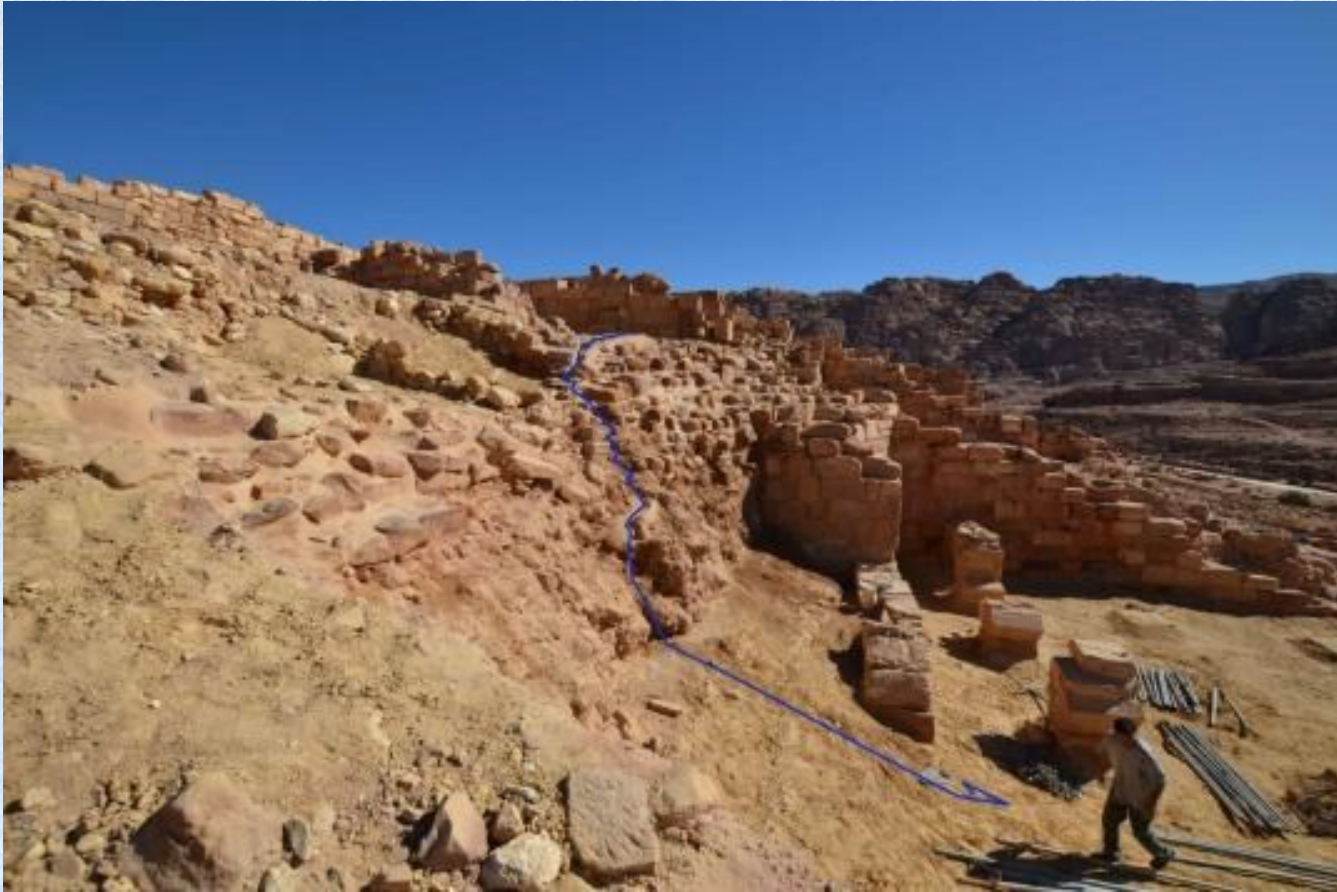
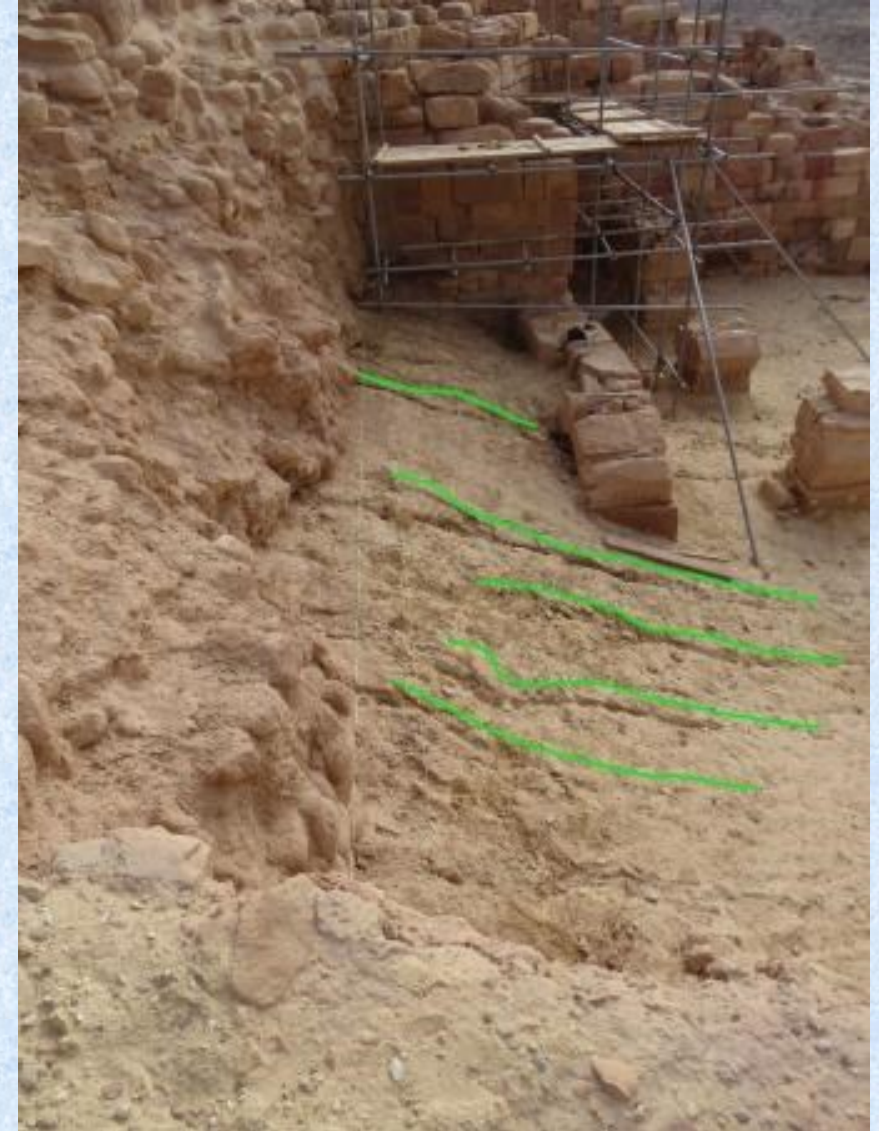
# Channels created by rainwater

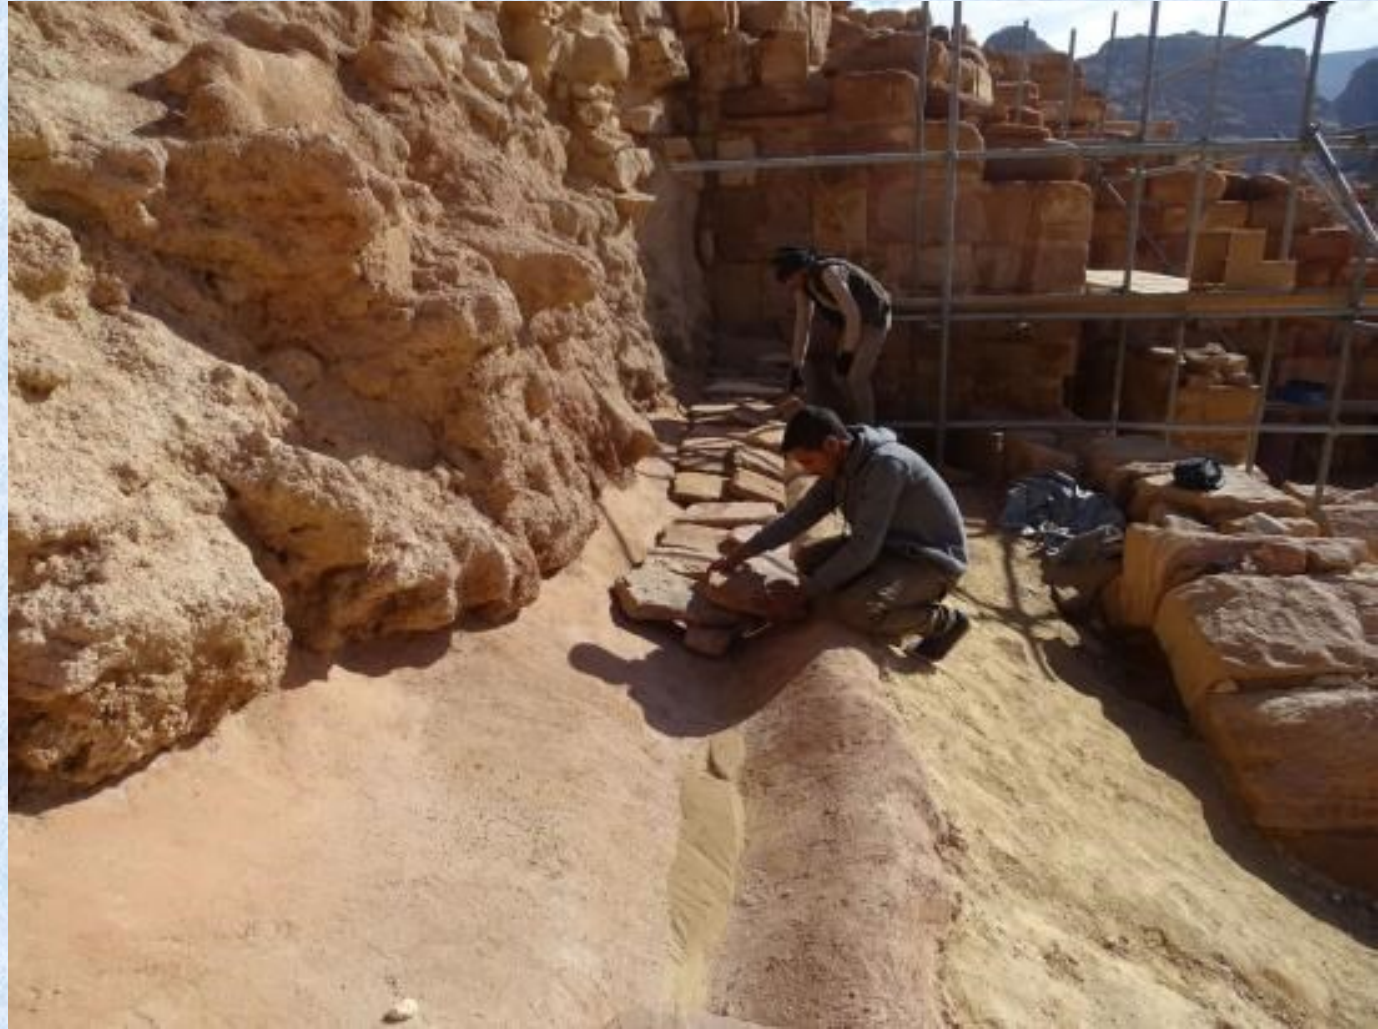
THE BOTTOM OF THE CHANNEL FOR THE FLOW OF THE RAINWATER

# New channel for rainwater
